# A Novel Approach for Antenna Structure Maintenance: Lowering and Replacement of Corroded Quadripod, CST structure

GMRT-NCRA

## C03 Antenna lowering and QPD rectification

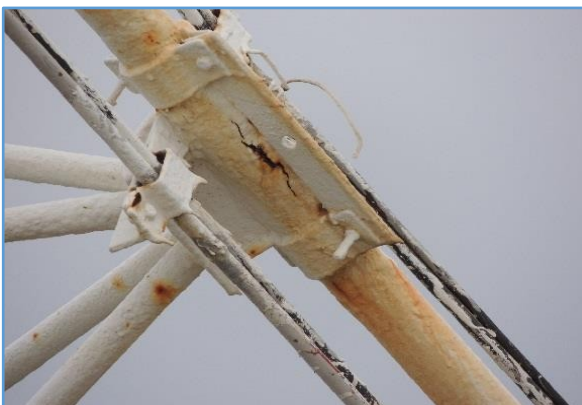
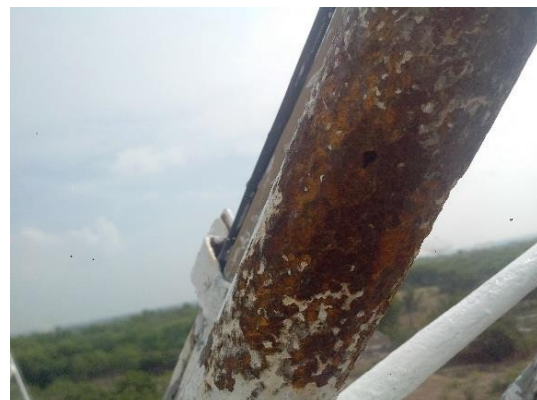
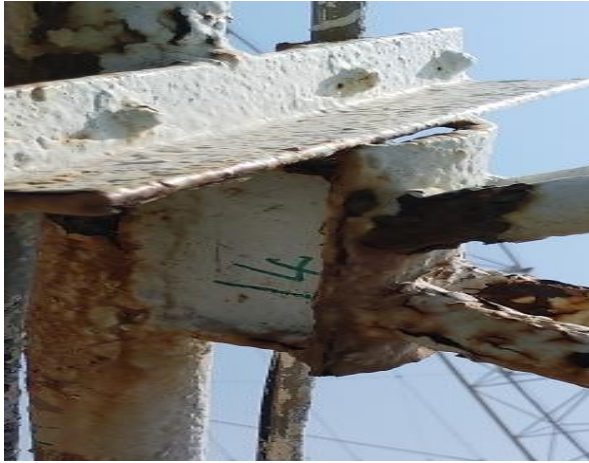
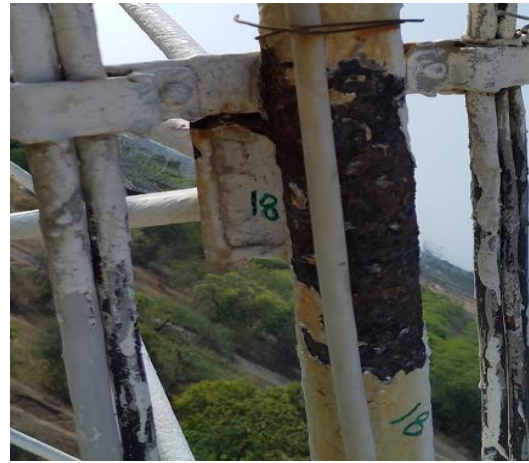
During the structural repair work on the RIM Section, it was observed that the QPD (Quadripod) pipes exhibited heavy pitting. To assess the extent of pitting, visual inspections were conducted, and a pitting depth gauge was used to measure the severity. Additionally, the presence of holes in the QPD Bottom pipe was identified, which seemed to be caused by water stagnation under the aluminium plate used for the mounting arrangement of the 50 MHz feed. This report outlines the findings of the pitting depth inspection conducted on the two QPD legs, with a focus on C03 QPD, and proposes a plan for periodic checks and comparisons to monitor any further deterioration.

- 2.8 mm max depth of pitting thickness observed on QPD resting on PRF 3
- 2.35 mm max depth of pitting thickness observed on QPD resting on PRF 15
- 2.19 mm max depth of pitting thickness observed on QPD resting on PRF 11
- 2.6 mm max depth of pitting thickness observed on QPD resting on PRF 7

Observations: Heavy pitting observed and three holes are observed on QPD structure

Immediate Remediation: Holes on QPD structures are closed by two half sleeve pipes to avoid further corrosion and entering of water inside the QPD structure

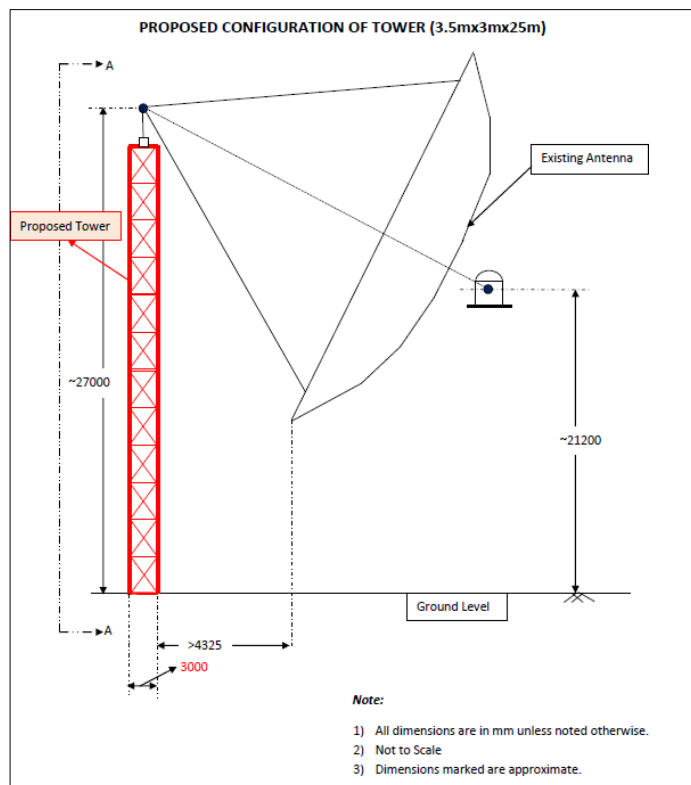
Configuration 01 involved designing a new tower and submitting the operation sequence for review by GMRT.

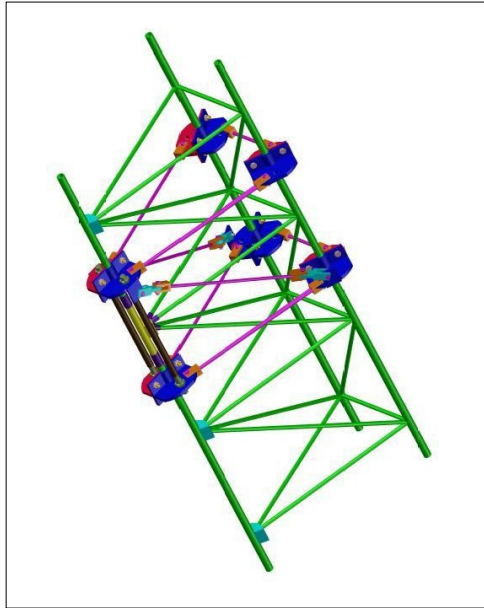
In Configuration 02, TCE recommended a local repair method to address observed holes in the structure. However, during inspection, it was discovered that heavy pitting affected the entire length of the pipe, making the local repair approach insufficient.

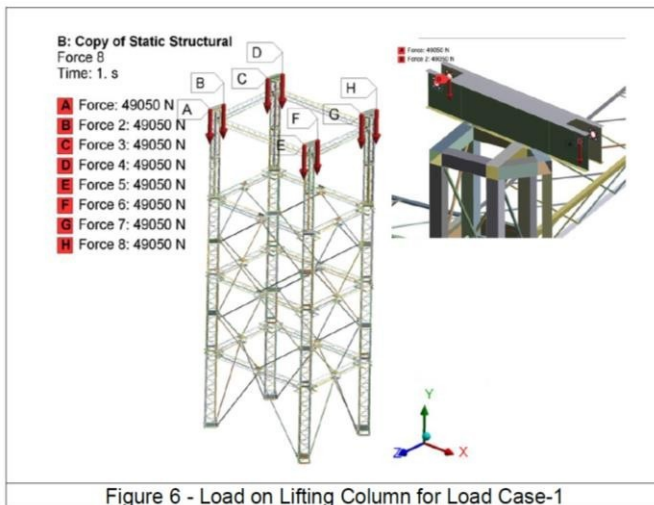
Figure 6 - Load on Lifting Column for Load Case-1

Based on the FEA analysis and the practical measurements conducted, it can be concluded that the lifting columns are safe to use. The FEA analysis likely indicated that the stress values and maximum deflection at full load condition are within acceptable limits, ensuring the structural integrity of the columns under the specified loading conditions.

Furthermore, a practical deflection test was conducted with a 1-ton load applied for 24 hours. Presumably, the deflection observed during this test was within acceptable limits, confirming the stability and performance of the lifting columns under practical conditions.

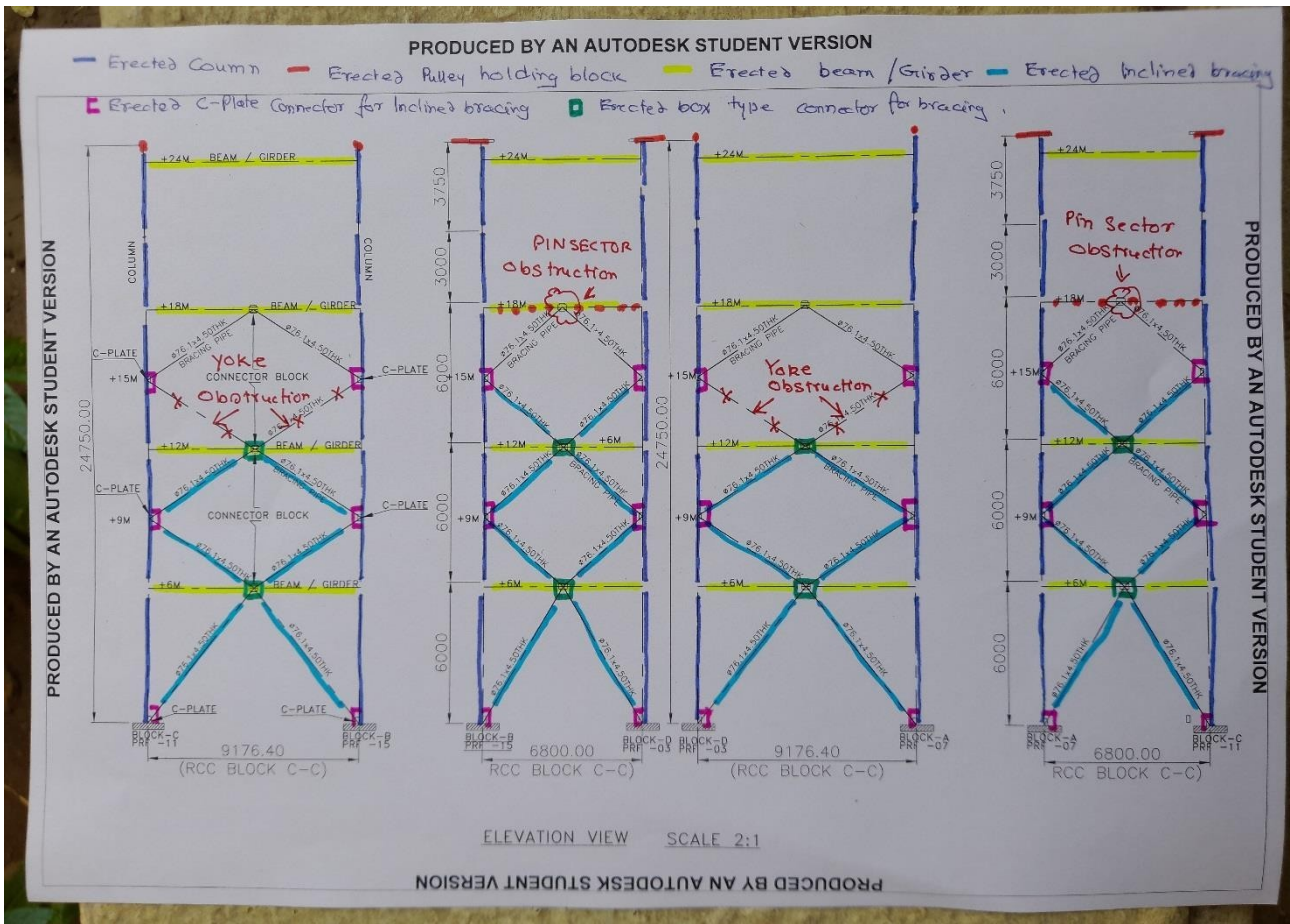
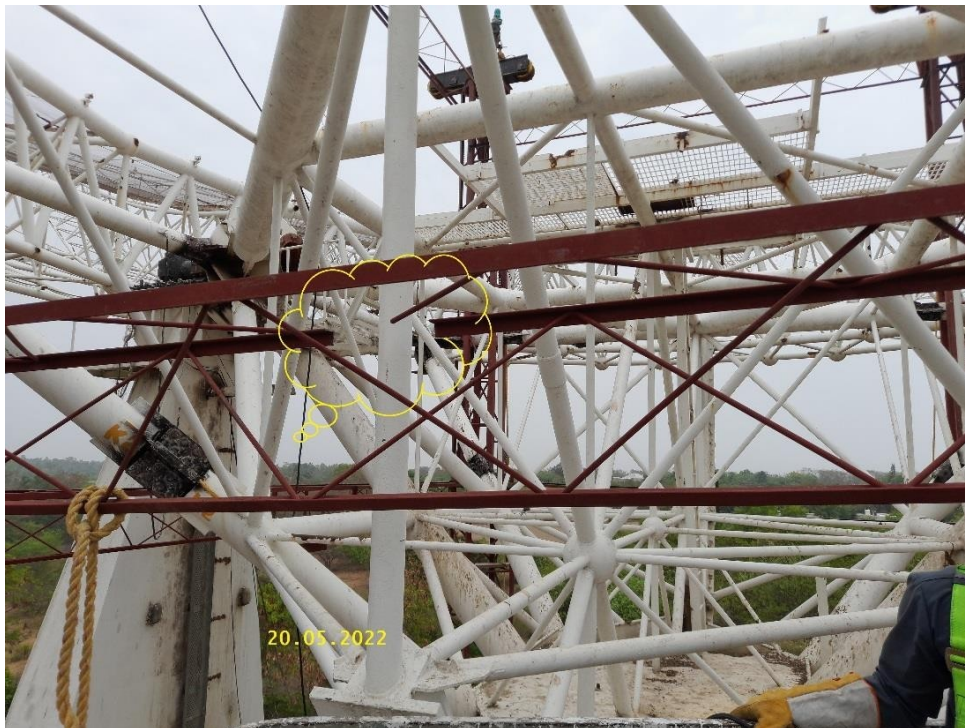
Girder fouling on Pin sector

After careful analysis, we made modifications to the fabrication process, incorporating changes based on what was observed in the old GMRT erection photos. These modifications were aimed at ensuring that the bracing members do not interfere with the antenna's functioning and movement.

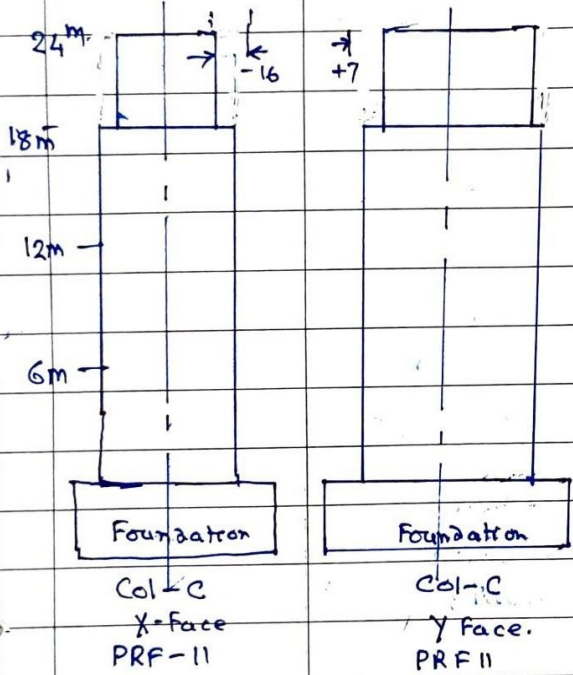
Hub Stool

Level (From foundation top)	Observation Verticality X-Face    Y-Face
			1) 0	0 mm    0
			2) 6m	-7 mm    0
			3) 12m	-14 mm    +2 mm
			4) 18m	-16 mm    +7 mm
			5) 24m	-16 mm    +7 mm
				(-) error    (+) error
				Col - C X-Face PRF-11
				Col - C Y-Face. PRF-11
				Note IS-12843 Acceptable Limit $\pm \frac{H}{1000}$ or $\pm 25$ mm (for Verticality) H - Height of Col.

Remarks: within acceptable limit

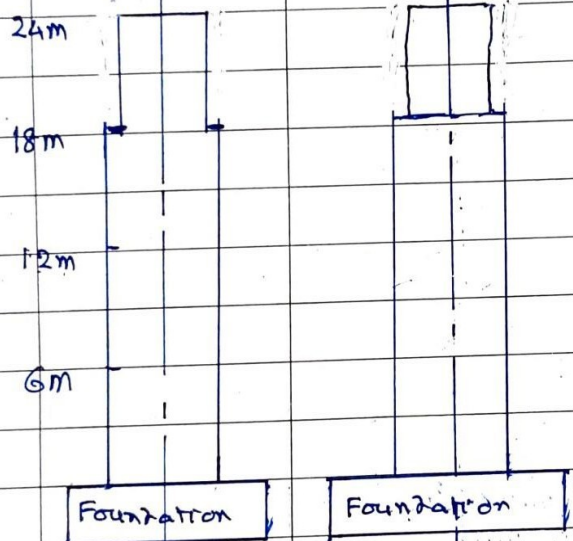
Level (From Foundation) Top	Observation - Verticality
			X-Face	Y-Face
		1) 0	0	0
		2) 6 m	+2 mm	+5 mm
		3) 12m	-3 mm	+8 mm
		4) 18 m	0 mm	-15 mm
		5) 24m	* -35 mm	-2 mm.
			* To be rectified.	
	Foundation	Foundation		
	Block-D	Block D		
	PRF- 03	PRF 3		
	X-Face	Y-Face.		
	Note 18812843	Acceptable Limit for Verticality	$\pm \frac{h}{1000}$ or $\pm 25$

Remarks: To be rectified

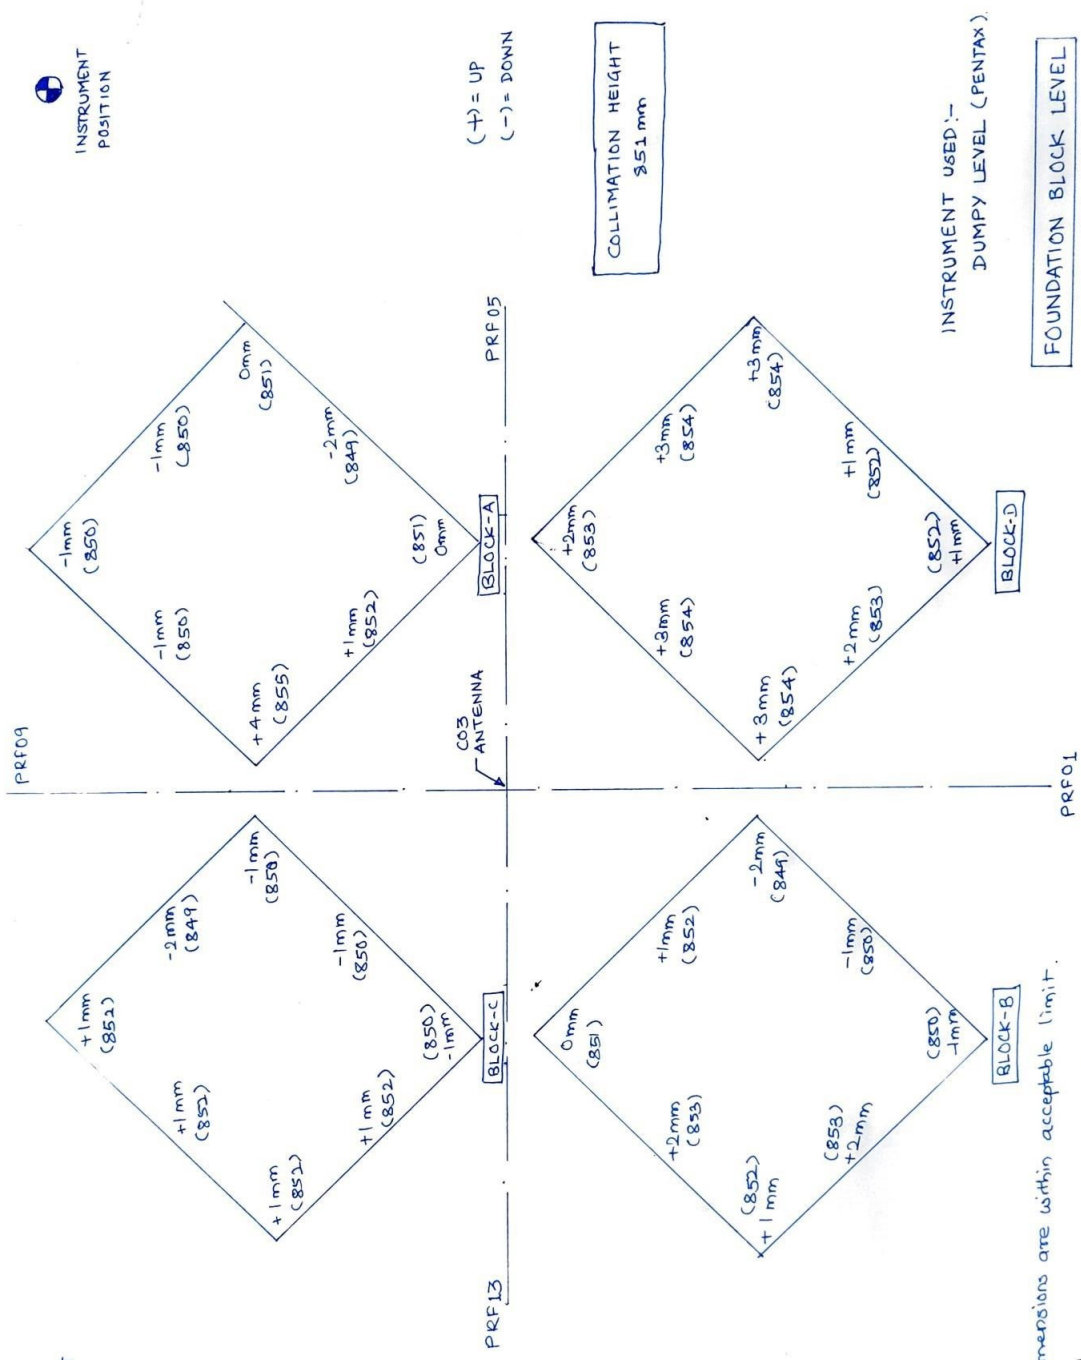
REMARK:- Dimensions are within acceptable limit.

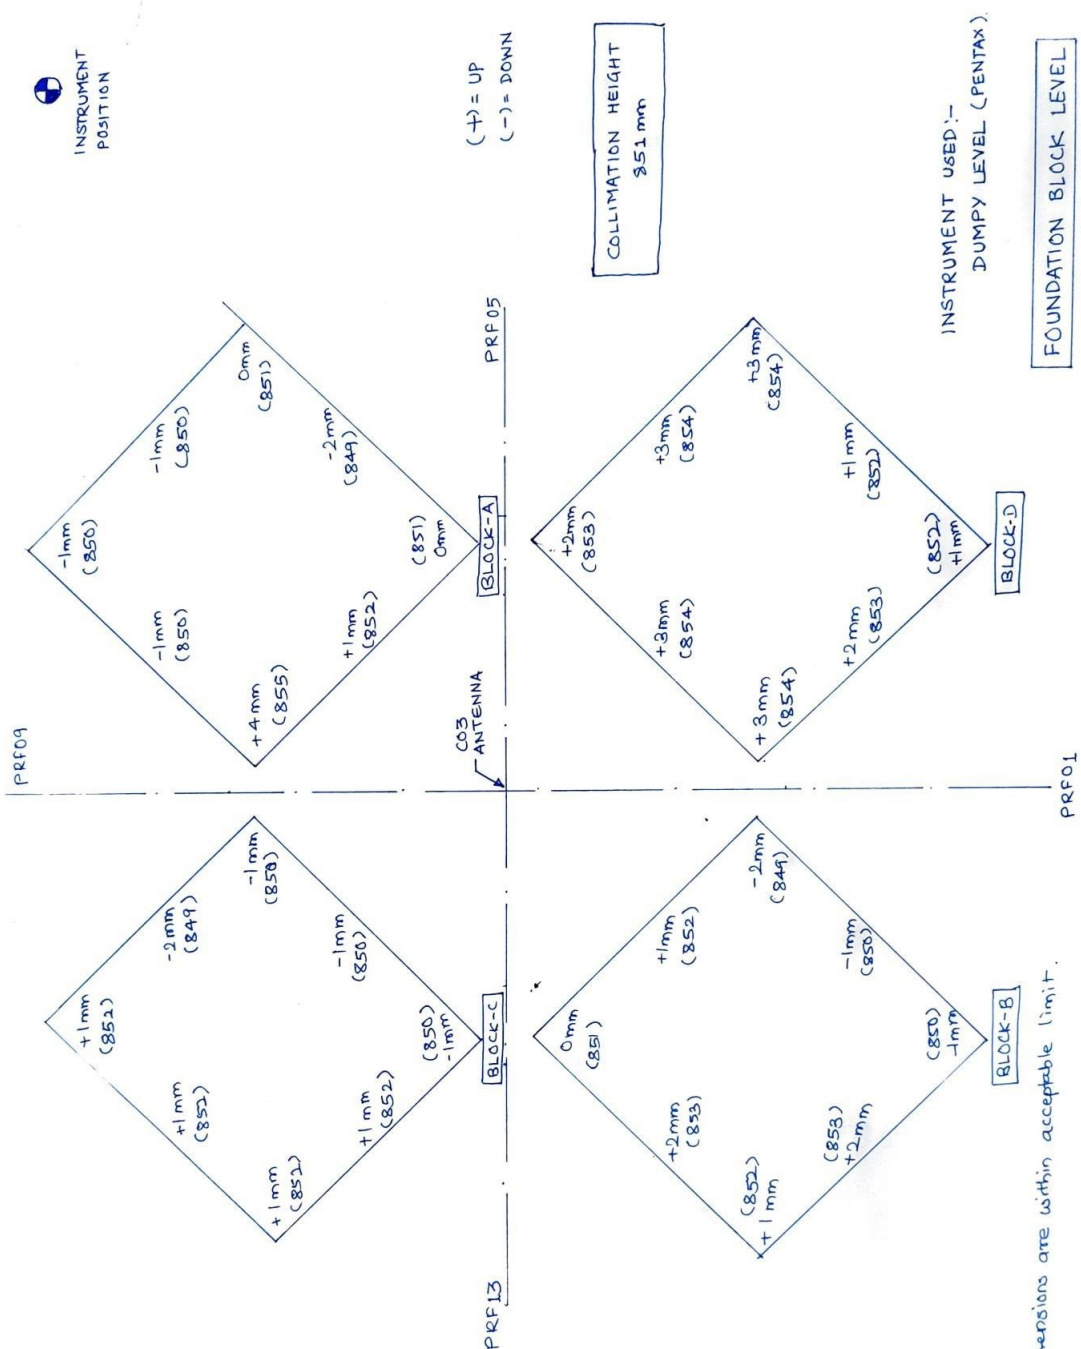
REMARK:- Dimensions are within acceptable limit.

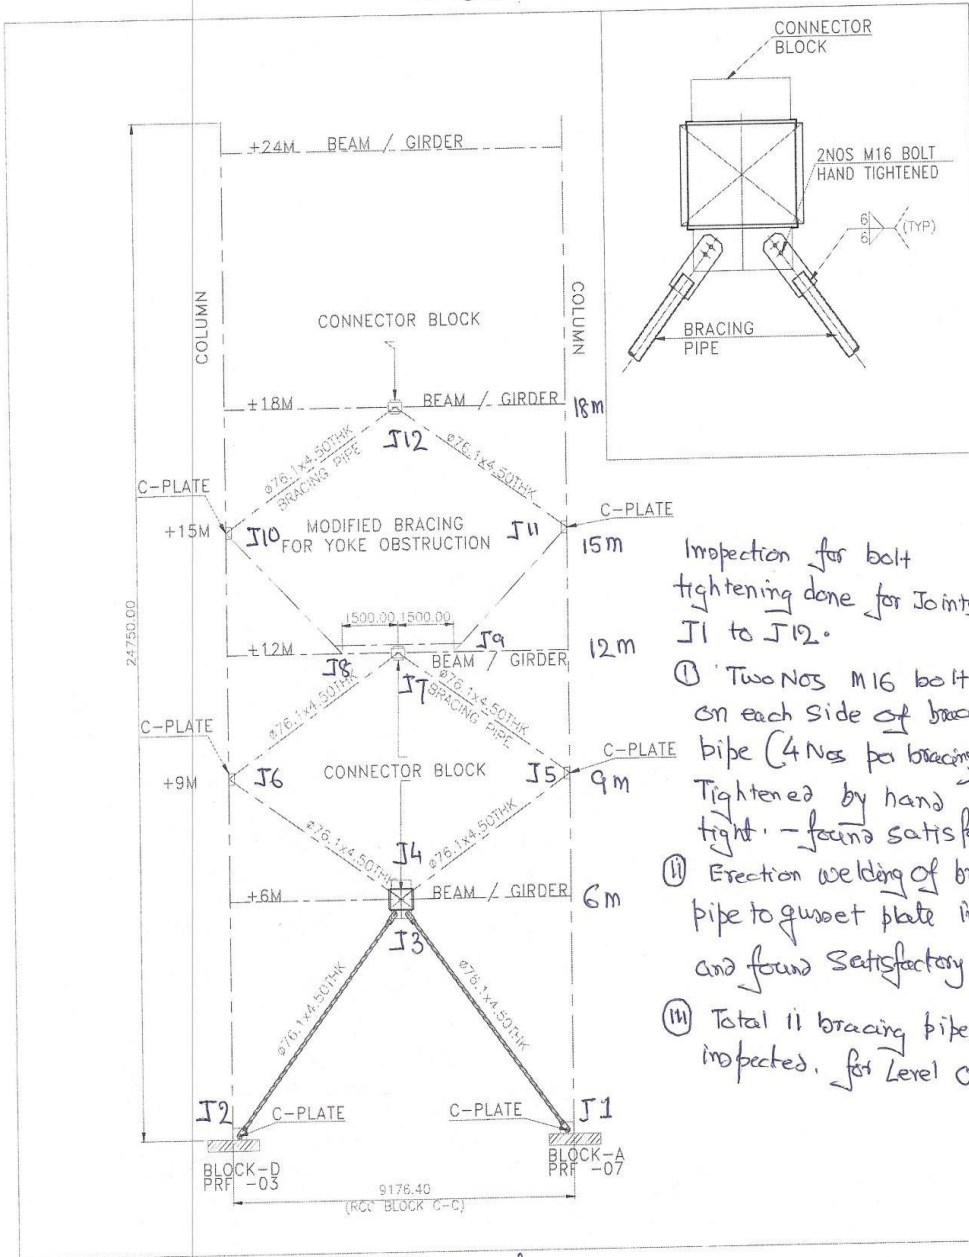
Face 3 PRF 03 - PRF 07  
Level 0m to 18m

- Inspection for bolt tightening done for Joints J1 to J12.
- (i) Two NOS M16 bolt on each side of bracing pipe (4 Nos per bracing) Tightened by hand tight - found satisfactory
  - (ii) Erection welding of bracing pipe to gusset plate inspected and found satisfactory
  - (iii) Total 11 bracing pipes inspected, for Level 0 to 18m

Note : 1) Additional bracing pipe provided at 12m level between to inclined bracing at 12-15m.  
2) Bracing between 12-15m offset by 1.5m, as discussed with ex TEE

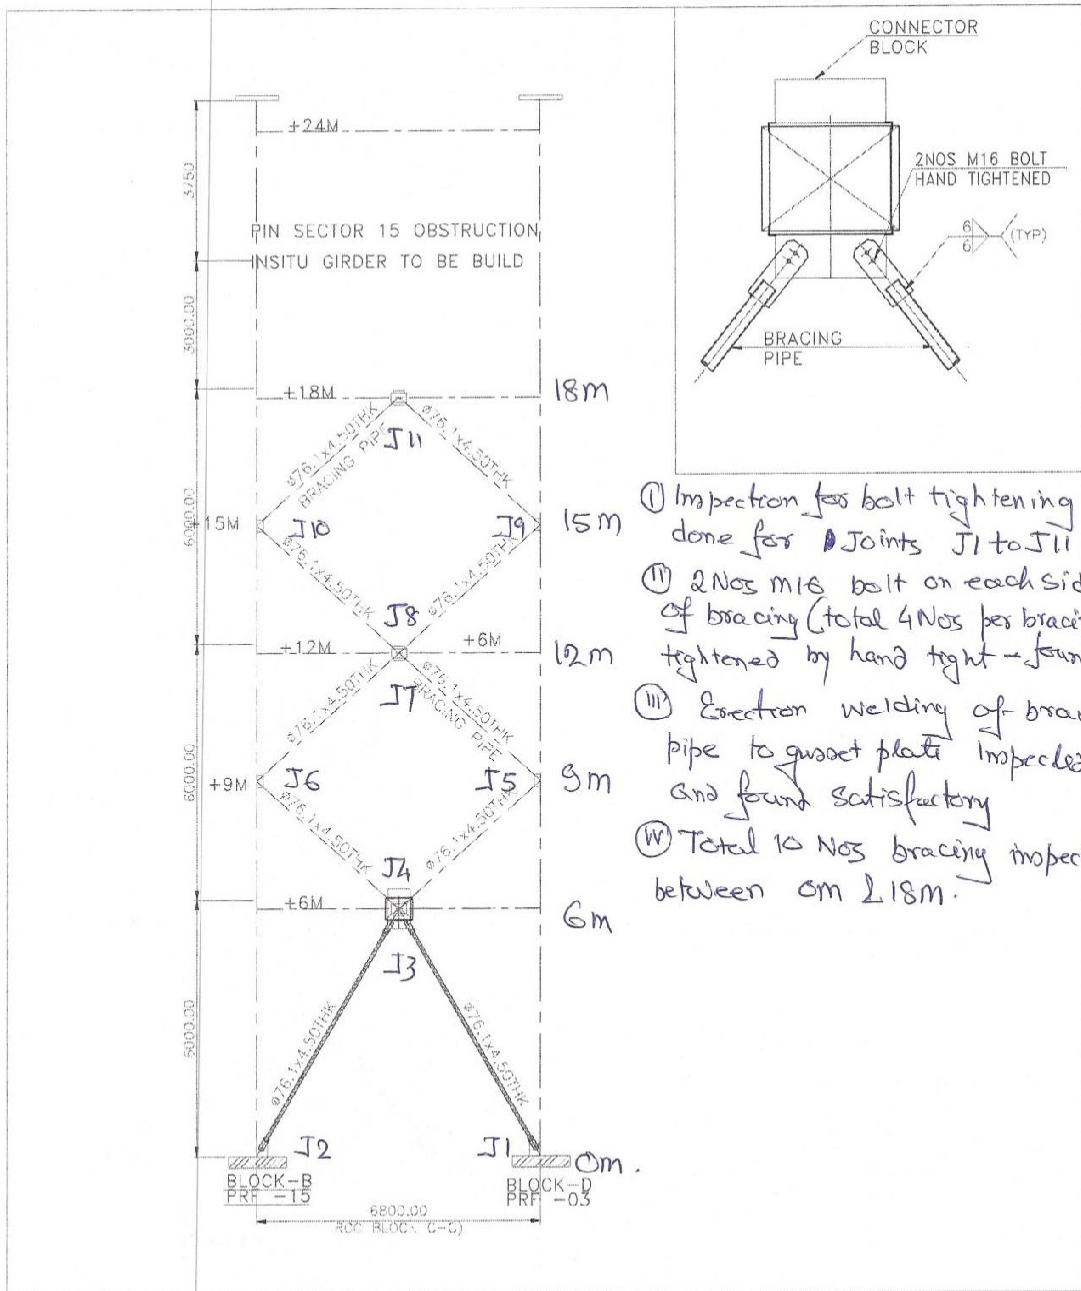
Level 0m to 18m

- ① Inspection for bolt tightening done for Joints J1 to J11
- ② 2 Nos M16 bolt on each side of bracing (total 4 Nos per bracing) tightened by hand tight - found OK
- ③ Erection welding of bracing pipe to gusset plate inspected and found satisfactory
- ④ Total 10 Nos bracing inspected between 0m & 18m.

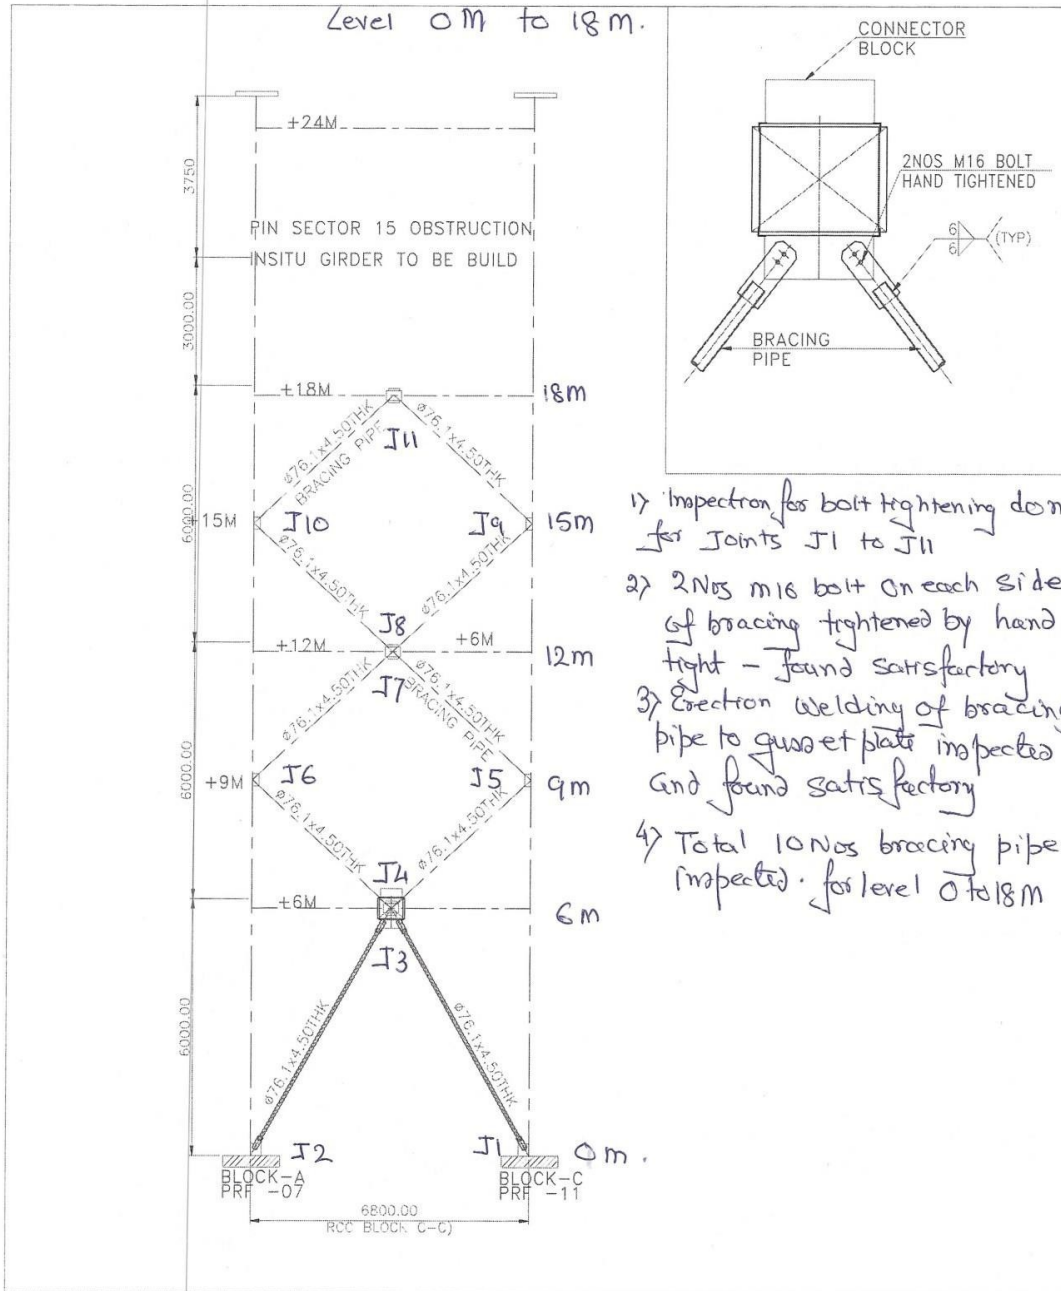
Inspection of inclined bracing pipes bolt joints & Erection Welding  
Face - PRF - 7 to PRF 11  
Level 0m to 18m.

- 1) Inspection for bolt tightening done for Joints J1 to J11
- 2) 2 Nos m16 bolt on each side of bracing tightened by hand tight - found satisfactory
- 3) Erection welding of bracing pipe to gusset plate inspected and found satisfactory
- 4) Total 10 Nos bracing pipe inspected for level 0 to 18m

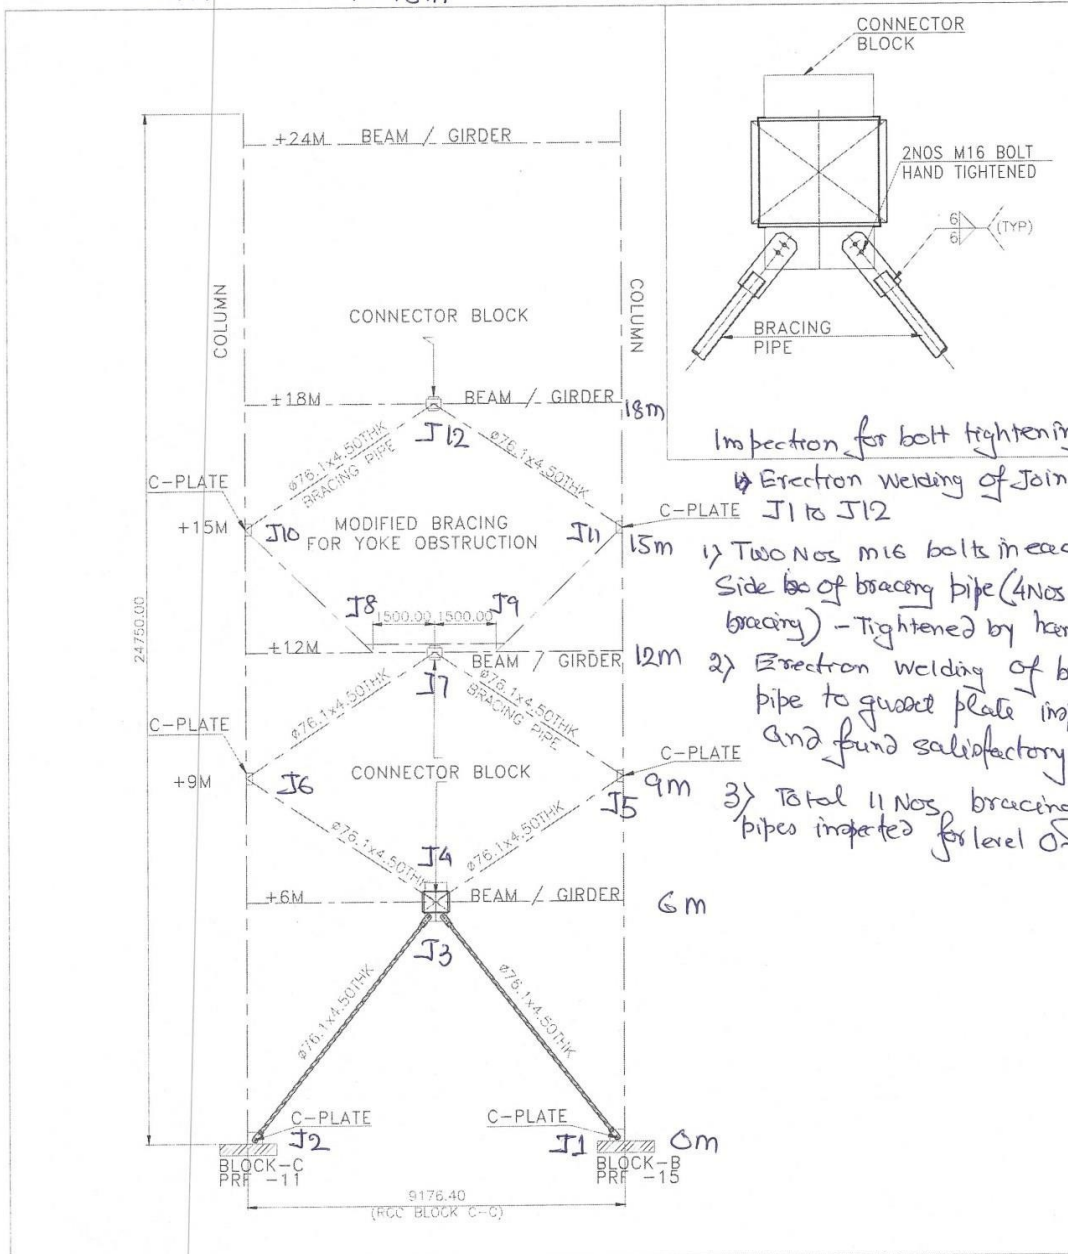
Level - 0m to 18m

- Note 1) Bracing between 12-15m offset by 1.5m as discussed with Ex TCE  
 2) Additional bracing pipes provided at 12m level between two inclined bracings of 12-15m level.

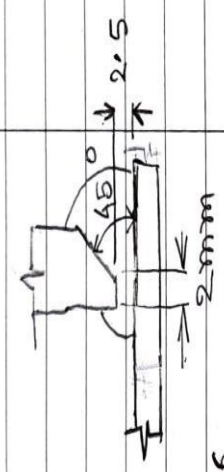
Dimensional checking - Overall dimension of box Sec checked as per drawing & found acceptable.		
		Root run check		
1)	Fitup	J 1 - Fitup checked & found ok		
		J 2 - Fitup checked & found ok		
		J 3 - Fitup checked & found ok		
		J 4 - Fitup checked & found ok		
2	Root Run DP Test	Observation		
	J1	- 4nos placed pinhole & slag Rectified ok.		
	J2	- 4nos placed pinhole & slag rectified ok.		
	J3	- 5nos placed pinhole & slag rectified ok.		
	J4	- 4nos placed pinhole & slag rectified ok.		
	Final weld visual			
	Stress Leaking	done on 26/4/2022	- 27/4/2022

Remarks: UT - UT of pulley assy blocks - Acceptable 27/4/2022  
See attached sketch for fitup & fixture detail
