# Radio Astronomy Centre

**27 YEAR-REPORT  
OF O.R.T.**

**(MECHANICAL)**

*1969 TO 1996*

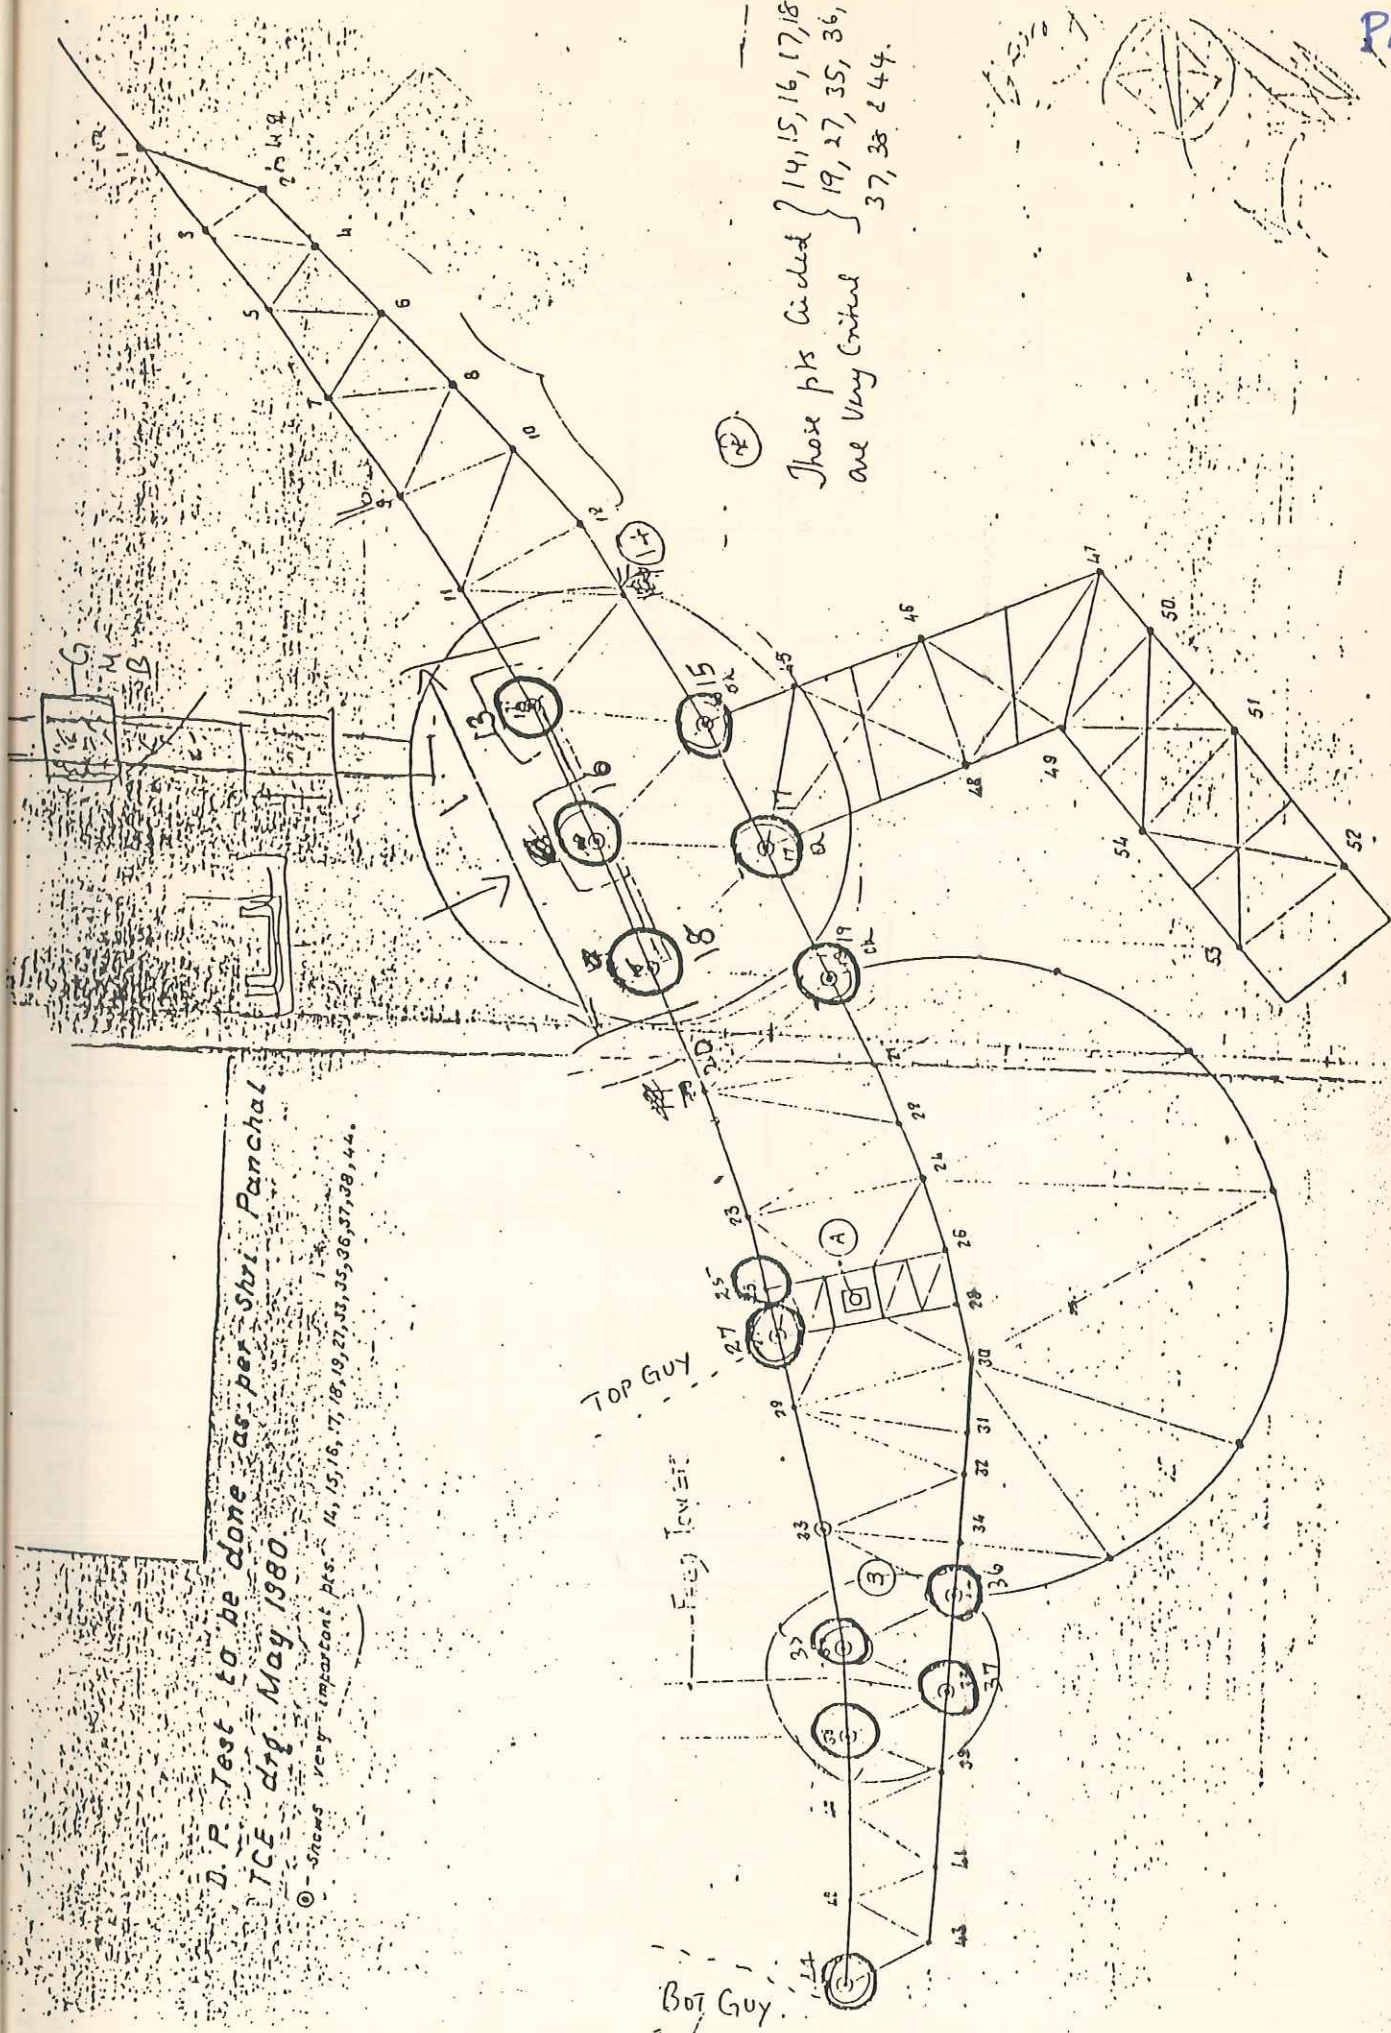
D.P. Test to be done as per Shri. Panchal  
 TCE dtg. May 1980.  
 Shows very important pts. 14, 15, 16, 17, 18, 19, 27, 33, 35, 36, 37, 38, 44.

Those pts circled  
 are Very Critical  
 14, 15, 16, 17, 18,  
 19, 27, 35, 36,  
 37, 38 & 44.

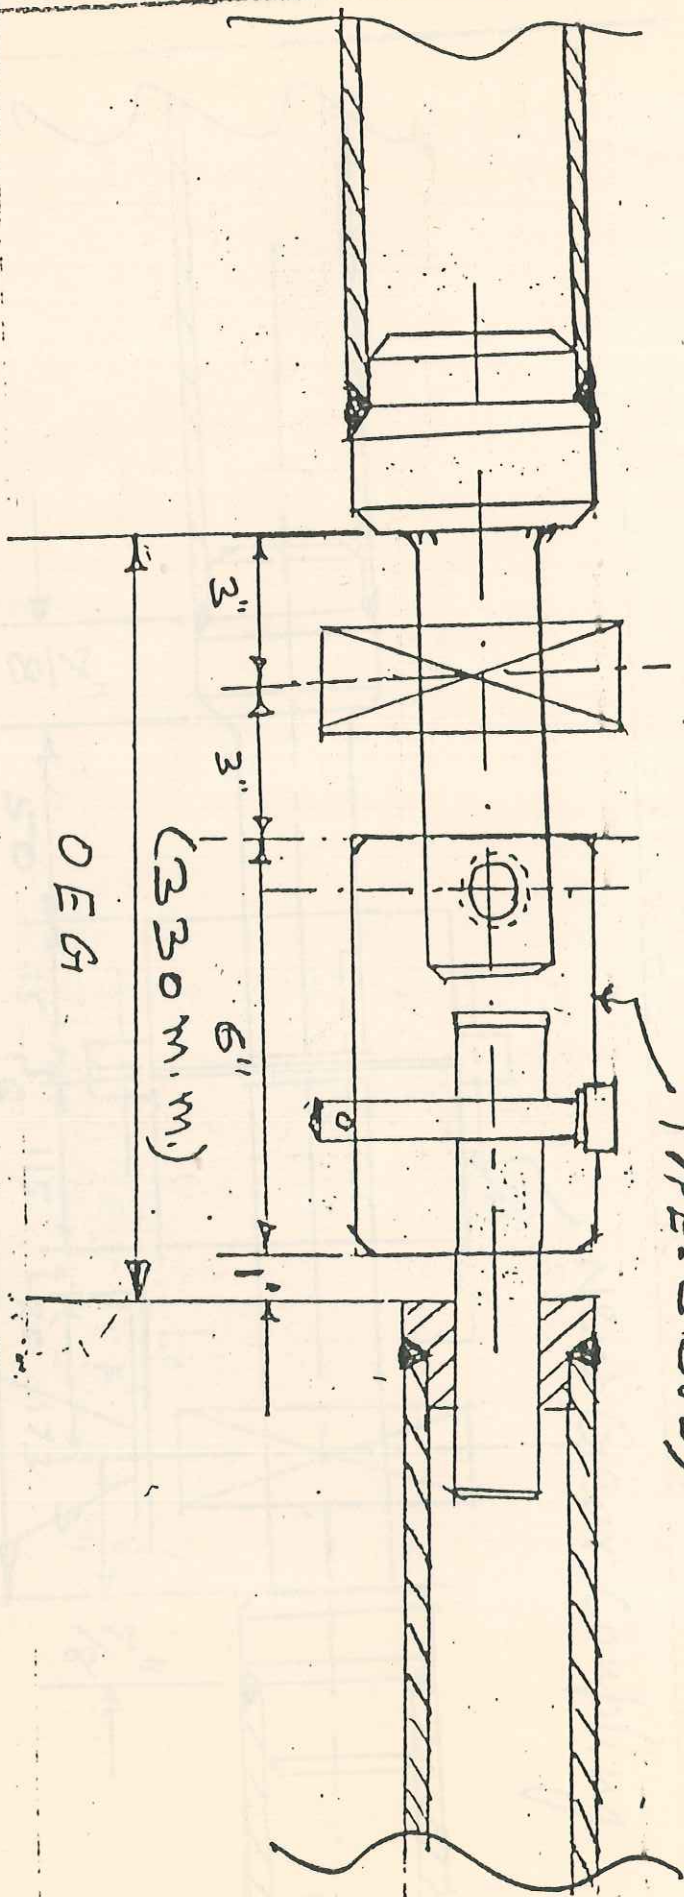
TYPE 'C' - [ 19717 ] - II<sup>nd</sup>

{Eventhough the Type"C"coupling worked the wear and tear and the noice is too much.Also as maintenance point of view it is very tiresome to carry out the correction works. So recently with the consultation of M/S.T.C.E. a NEW GEAR COUPLING was installed

between S2-S3. Center column in 9/95. which is a maintenance free system. Sofar the performance of coupling is satisfactory. Decided to fix in all the other center columns.}
