# A Novel Approach for Antenna Structure Maintenance: Lowering and Replacement of Corroded Quadripod, CST structure

GMRT-NCRA

## C03 Antenna lowering and QPD rectification

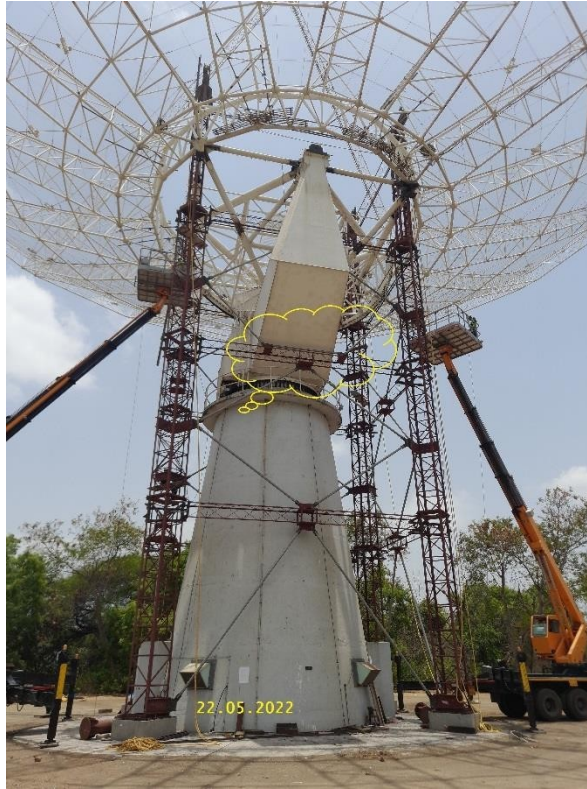
Bracing members are fouling @ Yoke body

By addressing the bracing member fouling issue and implementing the necessary changes, we have taken proactive measures to ensure the smooth and unobstructed functioning of the antenna during its operation. These modifications enhance the overall efficiency and effectiveness of the column's erection, contributing to the successful completion of the project.

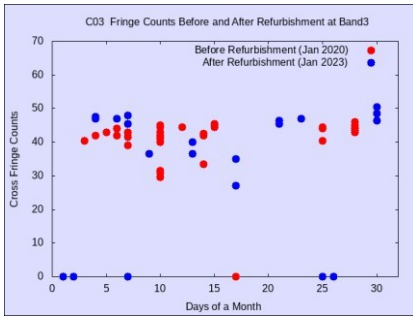
Band 3 increased by 3.14 %

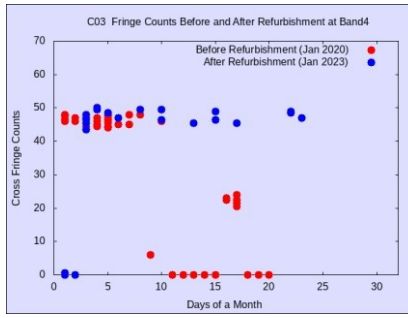
Band 4 increased by 4.7%

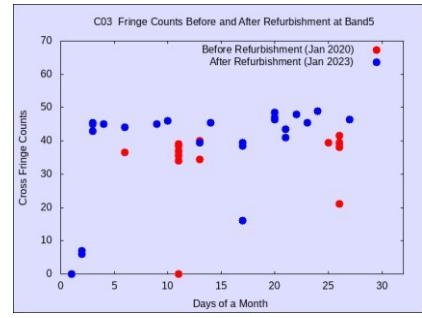
Band 5 increased by 19.5%

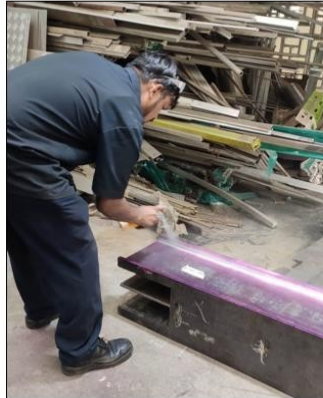
DP Test

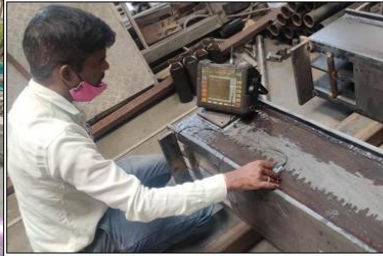
UT Test

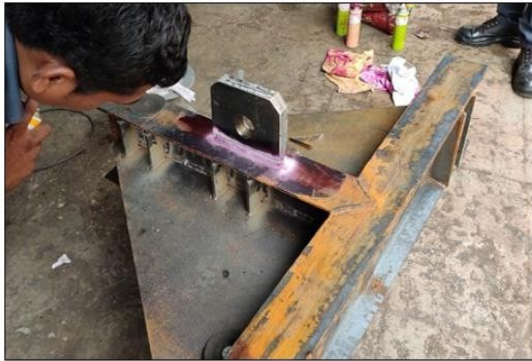
DP Test

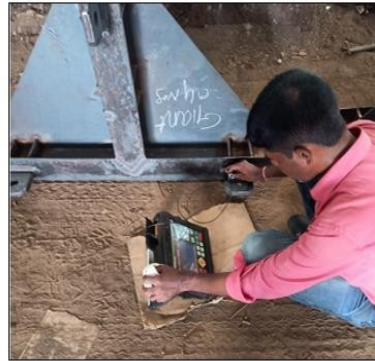
UT Test

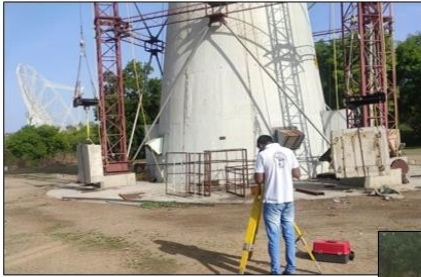
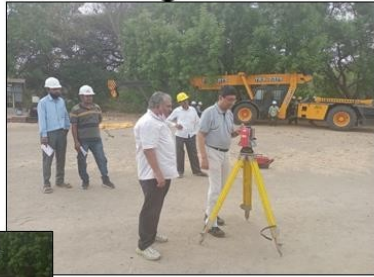
### Erection Column alignment checking

Accuracy of column is maintained within 15 mm As per IS 12843 acceptance limit of the 25 mtr structure is 25 mm

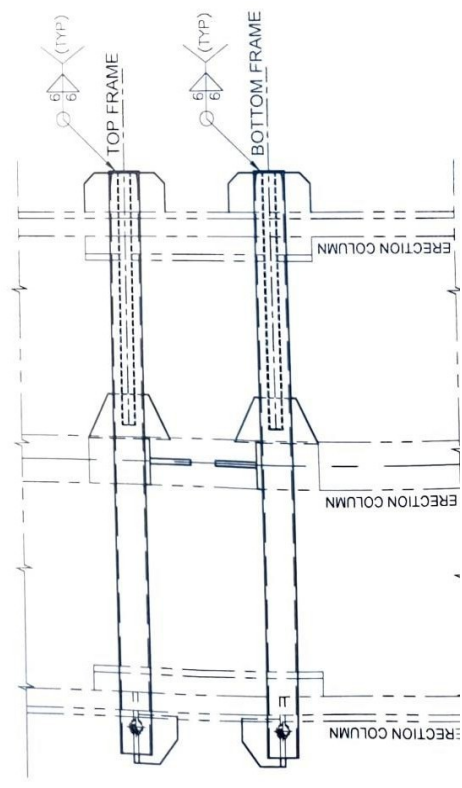
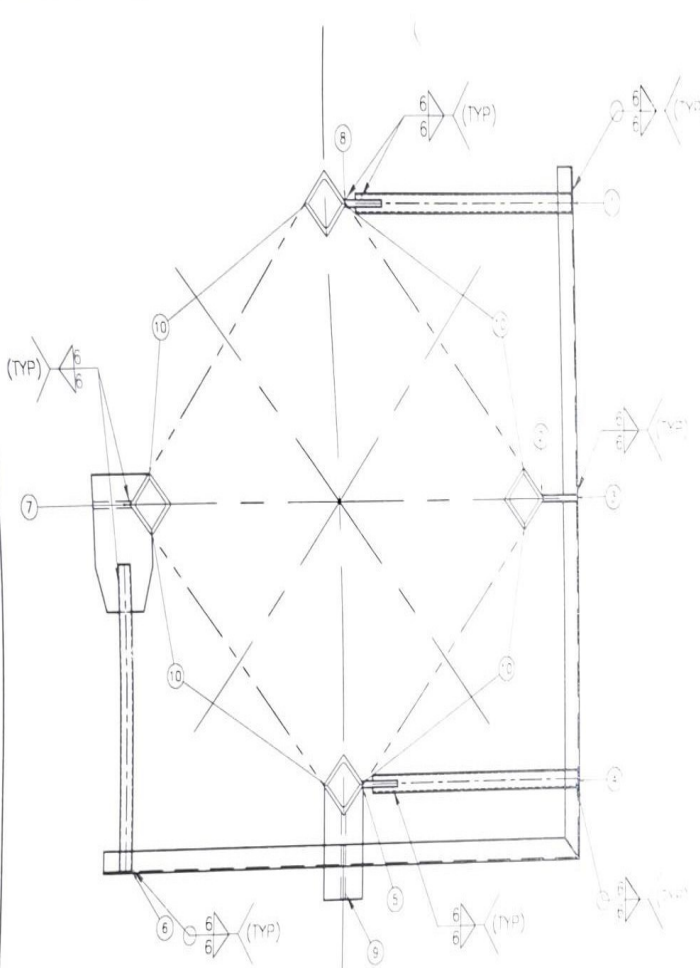
**VISUAL WELDING INSPECTION REPORT FOR COLUMN TO TRIANGULAR GIRDER.**

SR. NO.	ITEM	QTY.	INSPECTION REMARKS
01	<i>column to triangular girder weld joint at 6 meter level</i>	<i>08 junction</i>	<i>Carried out visual inspection of all 8 junctions checked all points of all 8 junctions as per the attached sheet &amp; found satisfactory in all respects. Released for further work</i>

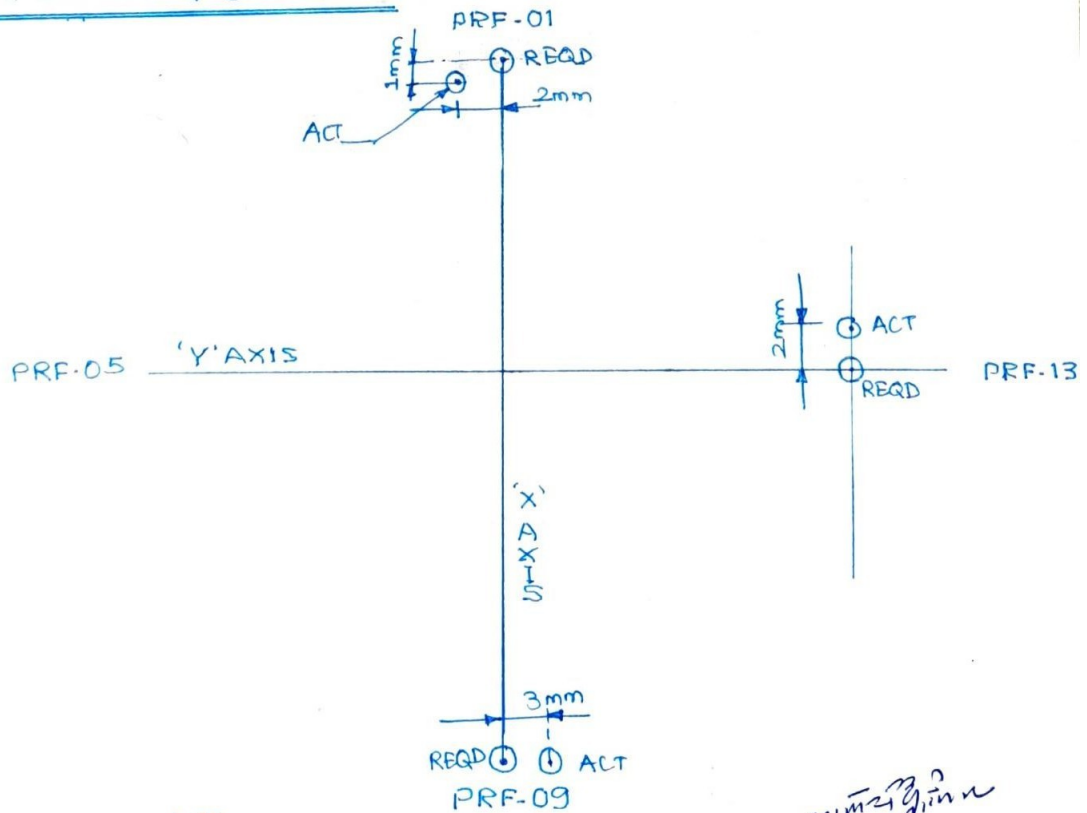
DISH CENTERING (PLAN VIEW)

During the inspection of the old CST structure, we observed a deviation where the CST was shifted to one side, resulting in misalignment with the centre of the dish structure. Recognizing the importance of proper alignment for optimal performance, we promptly decided to address this issue.

CRADLE CON. PT. NO.	READING	PLUS / MINUS
03	255 mm	0
07	256 mm	+1
11	255 mm	0
15	255 mm	0

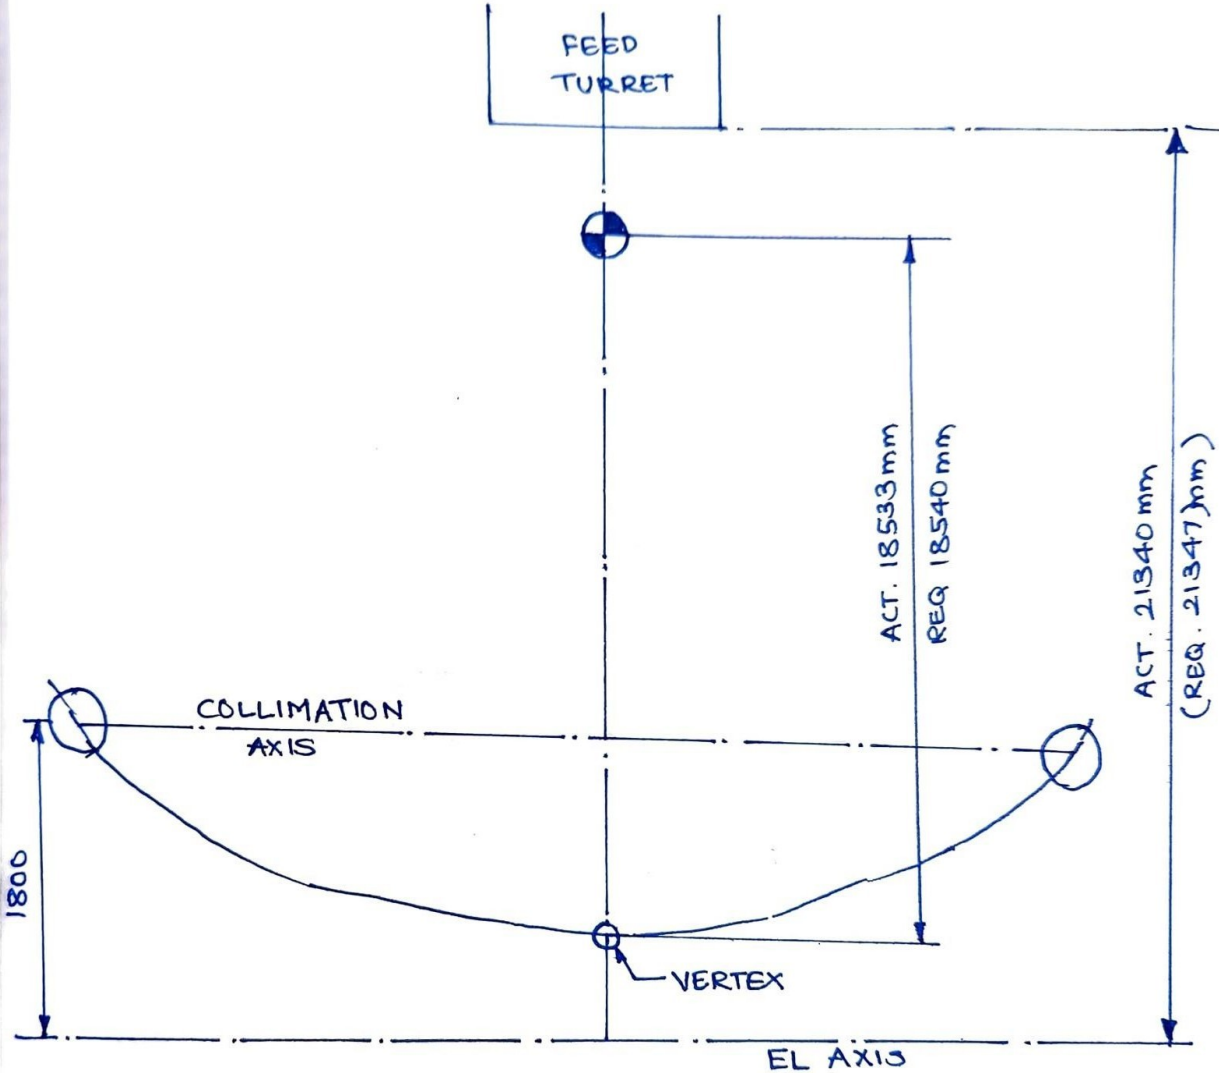
C03 ANTENNA FOCAL LENGTH - AFTER QPD ERECTION

- After measuring the focal length of the antenna before replacement of QPD we found a deviation of 24 mm on the higher side compared to the theoretical value of focal length, we took corrective actions during the erection of the QPD and CST structures to rectify this issue.

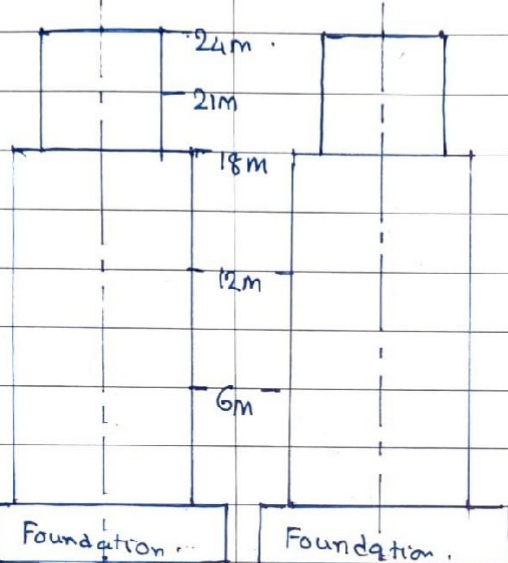
① → At 0m from Foundation block ② → + 6m ③ → + 12m ④ → + 18m ⑤ → + 21m ⑥ → + 24m	For PRF No wise deviation/Column Verticality Please see attached sheet.
		1) measurements taken at final stage after erection & welding of all triangular girders, inclined bracings, and before load testing.		
		2) Acceptable limit $\pm 25\text{mm}$ . (IS 12843)		
		3) Results given in attached sheet & found satisfactory.

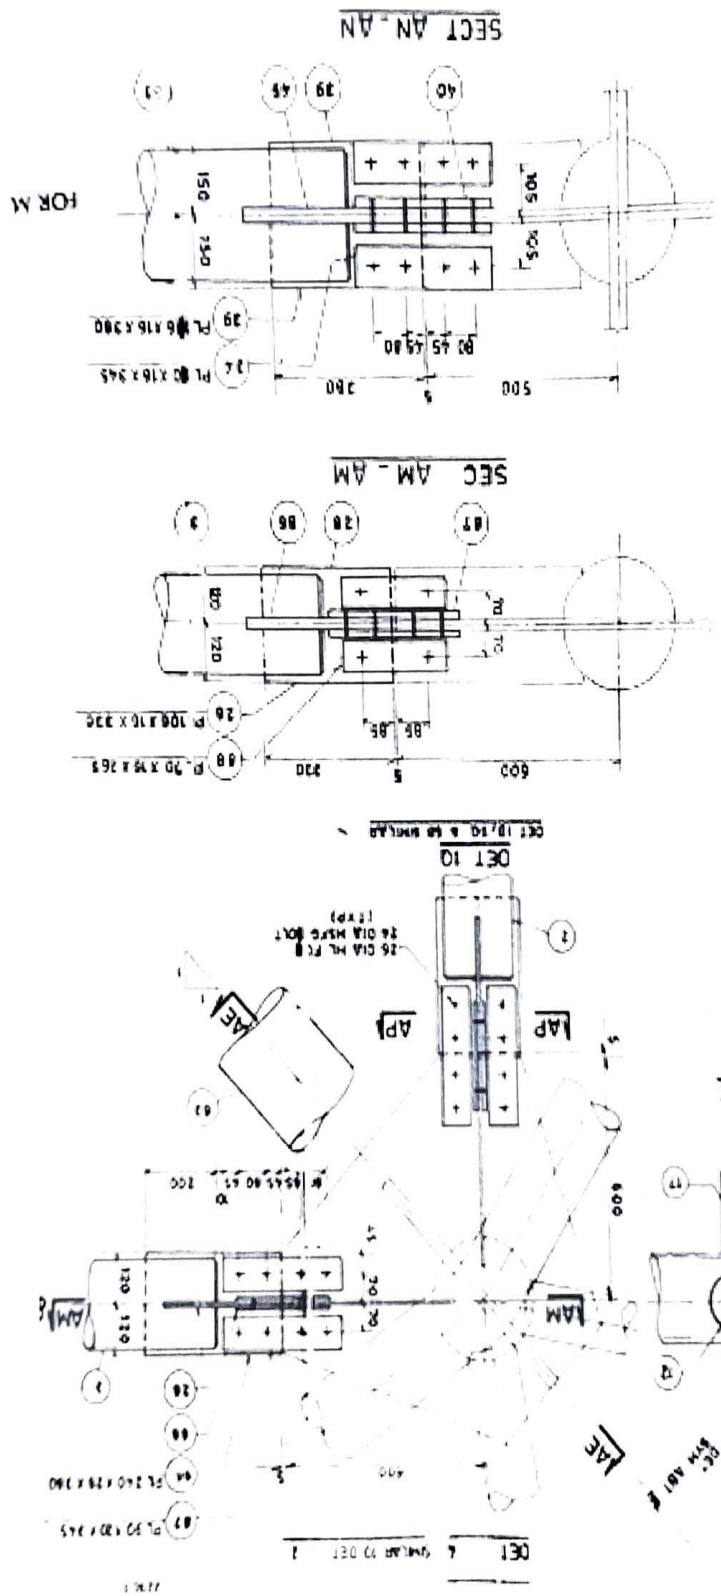
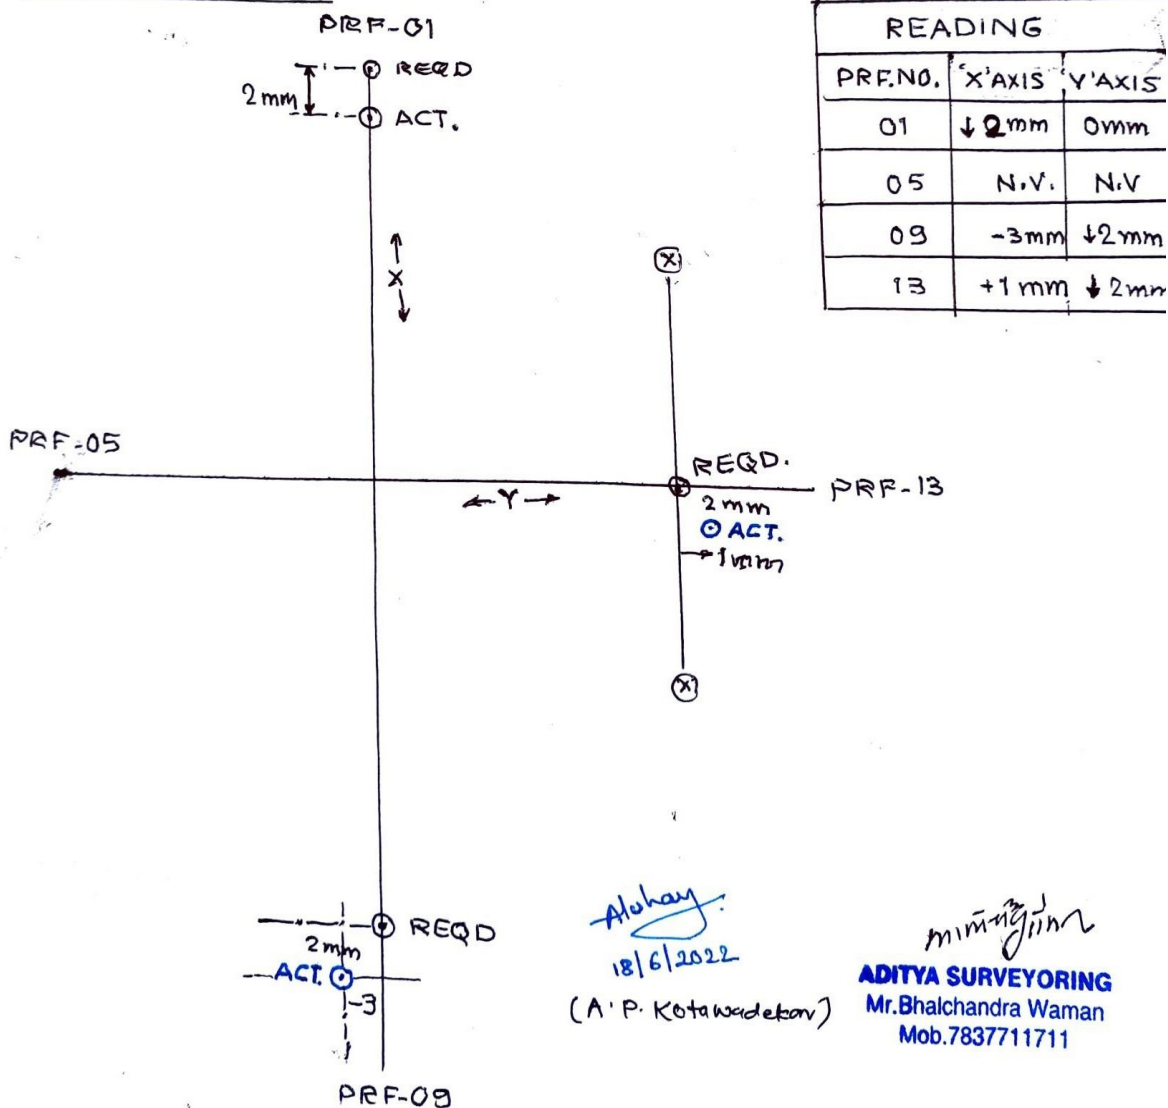
C-03 ANTENNA

CRADLE CON. PT. NO.	READING	PLUS/MINUS
03	236 <del>233</del> mm	-3.0 mm
07	238 mm	-1.0 mm
11	239 mm	0.0 mm
15	237 mm	-2.0 mm

DISH CENTERING

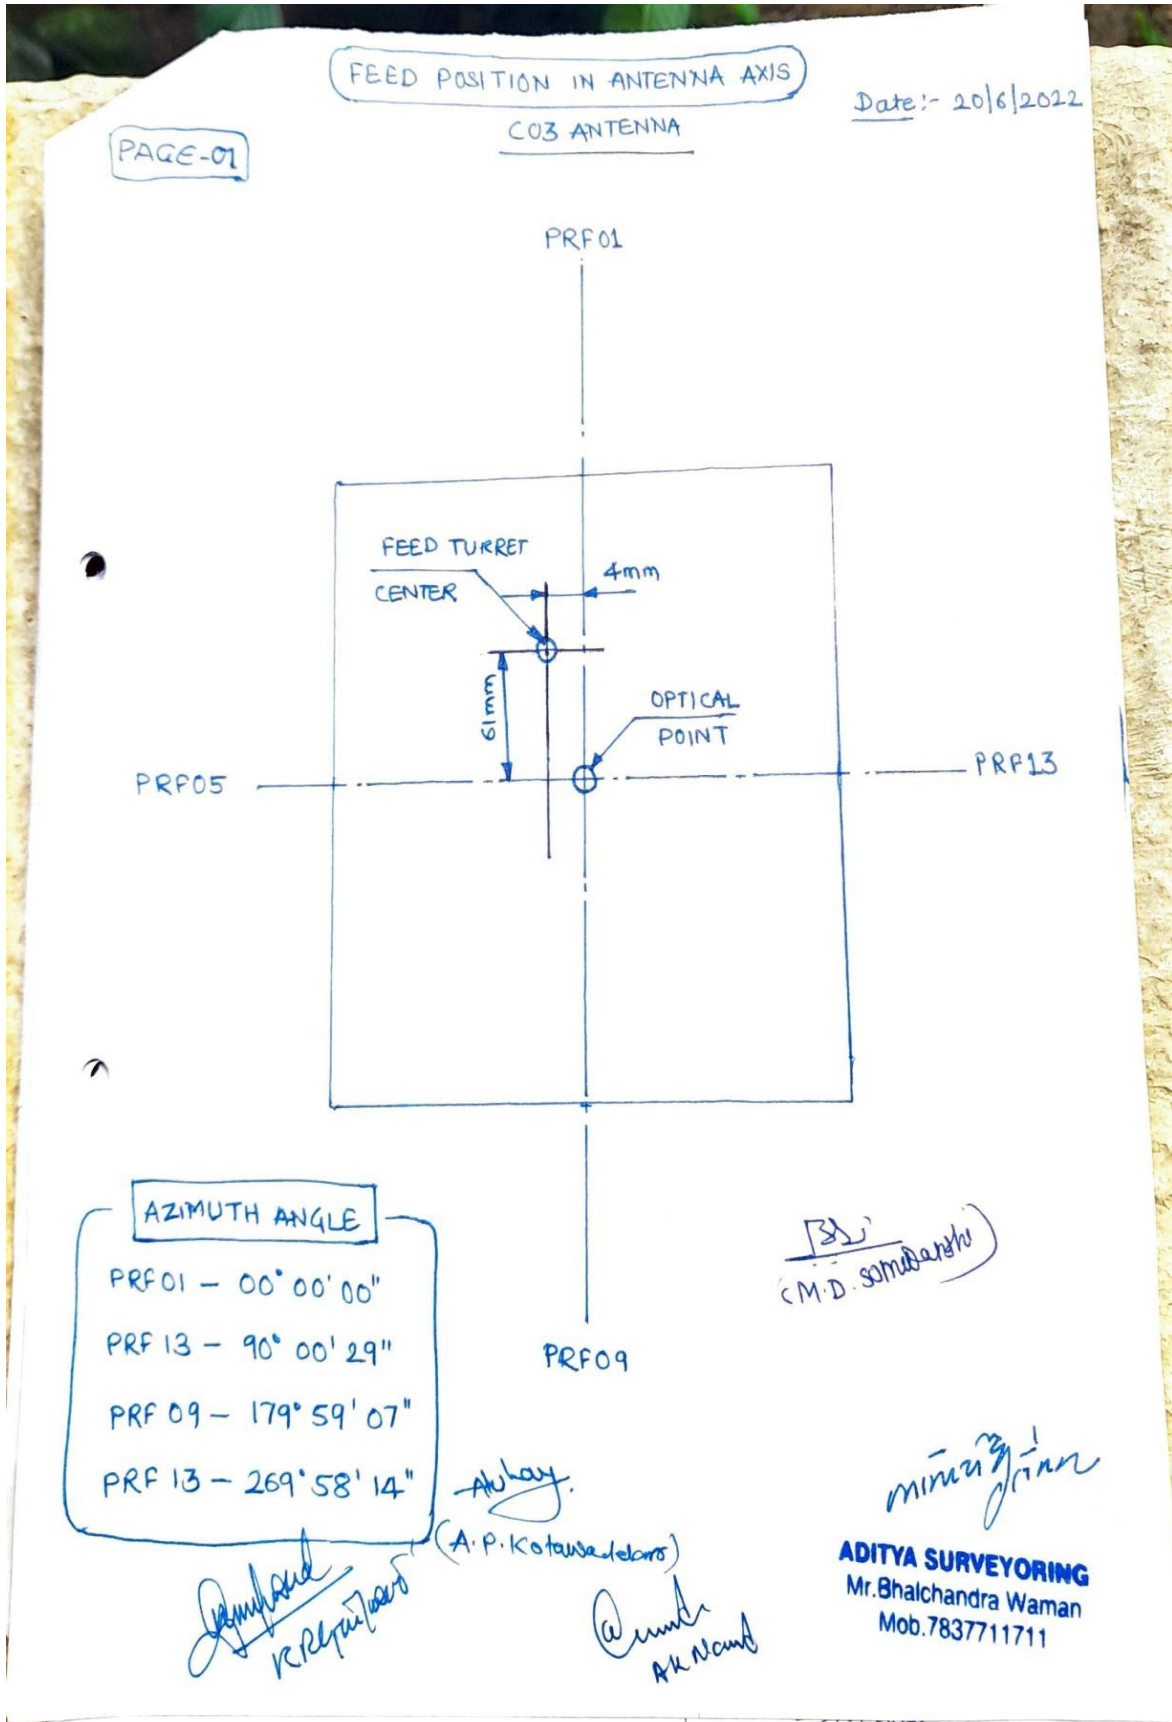
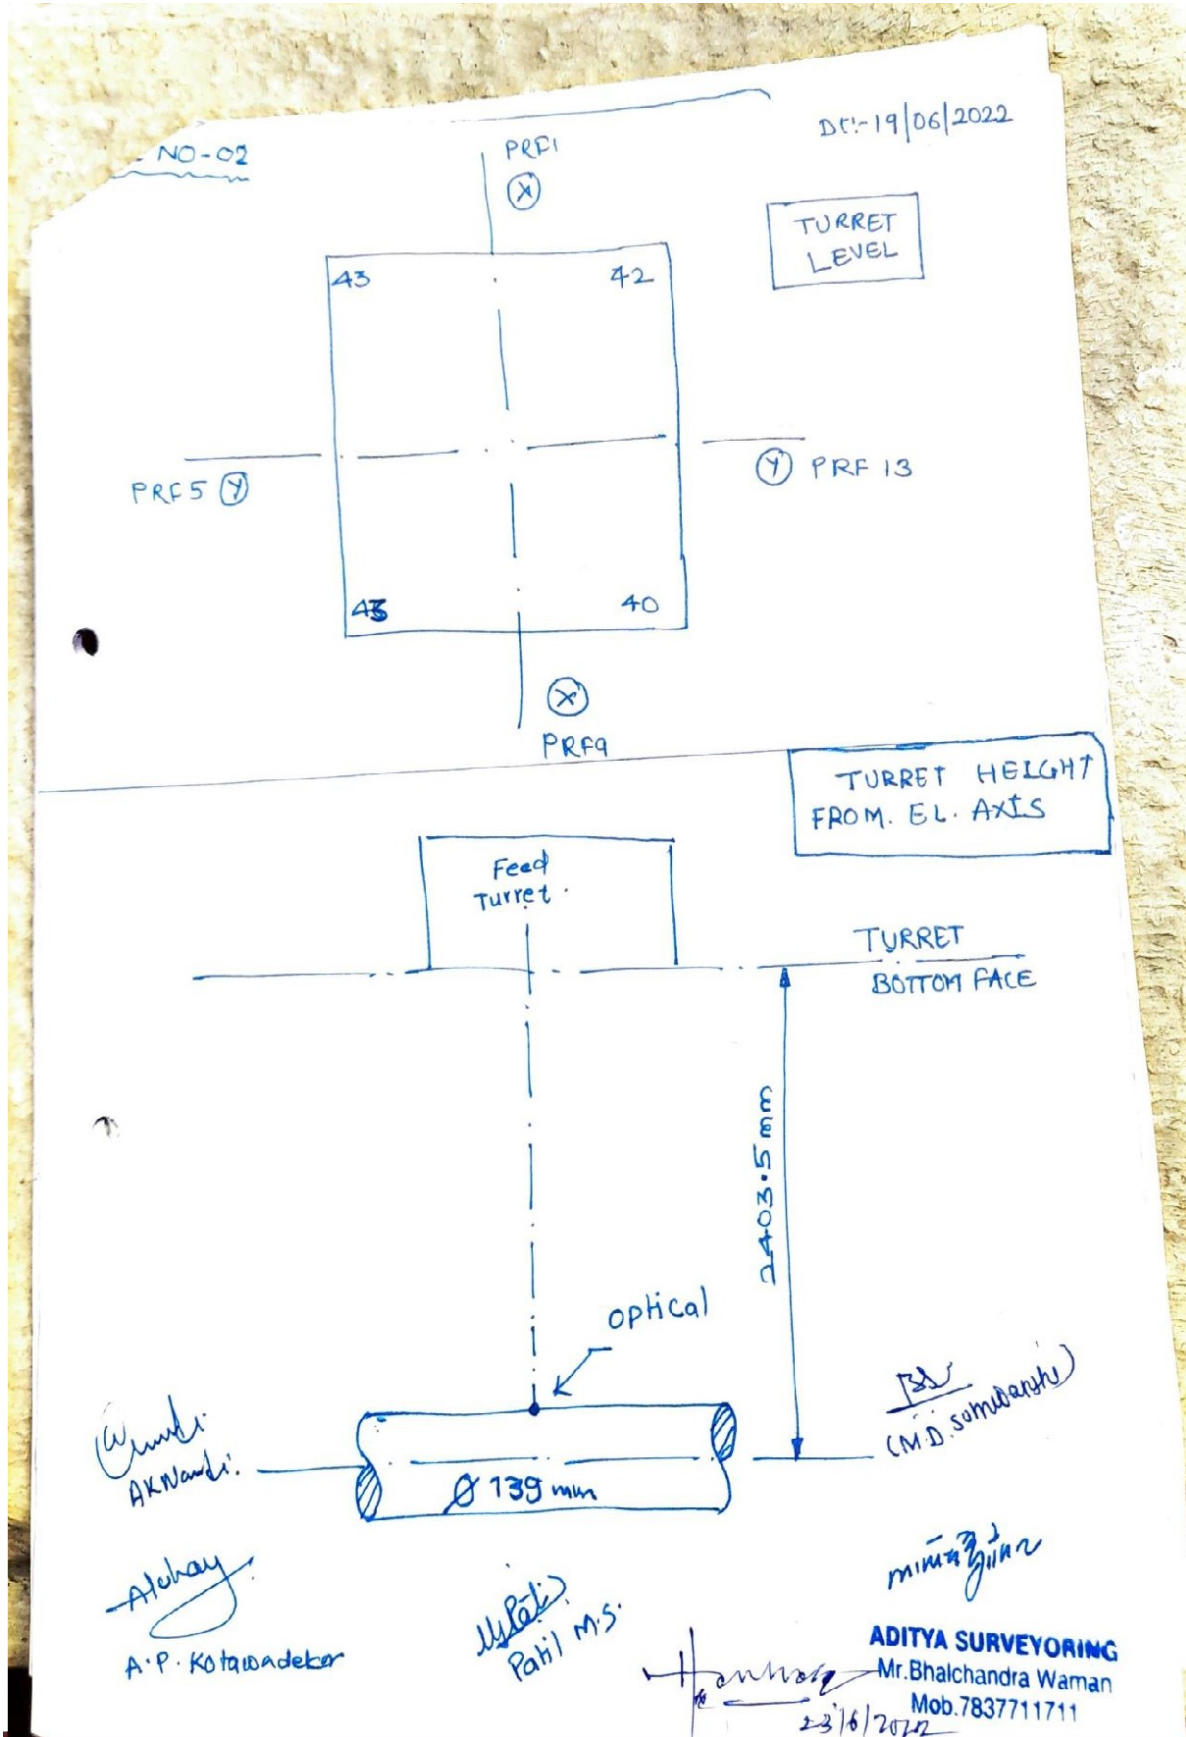
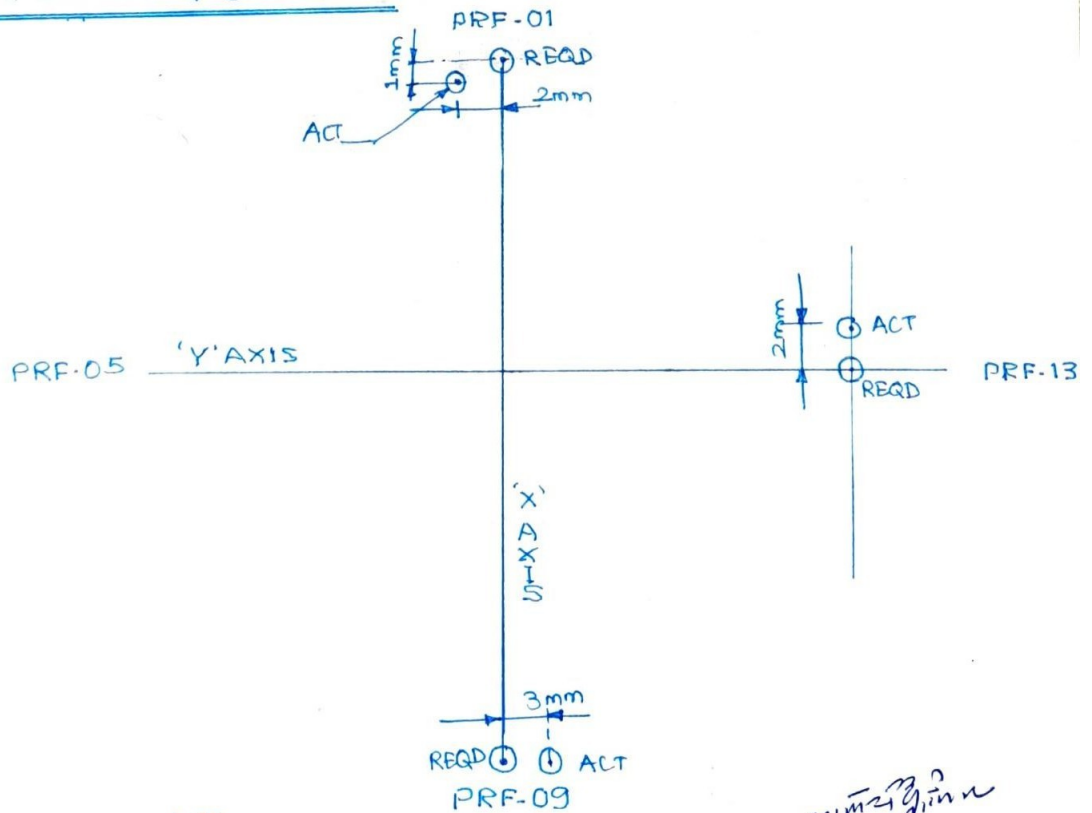
**C03 ANTENNA**

CRADLE CON. PT. NO.	READING	PLUS / MINUS
03	255 mm	-
07	256 mm	+1
11	255 mm	0
15	255 mm	0

DISH CENTERING (PLAN VIEW)

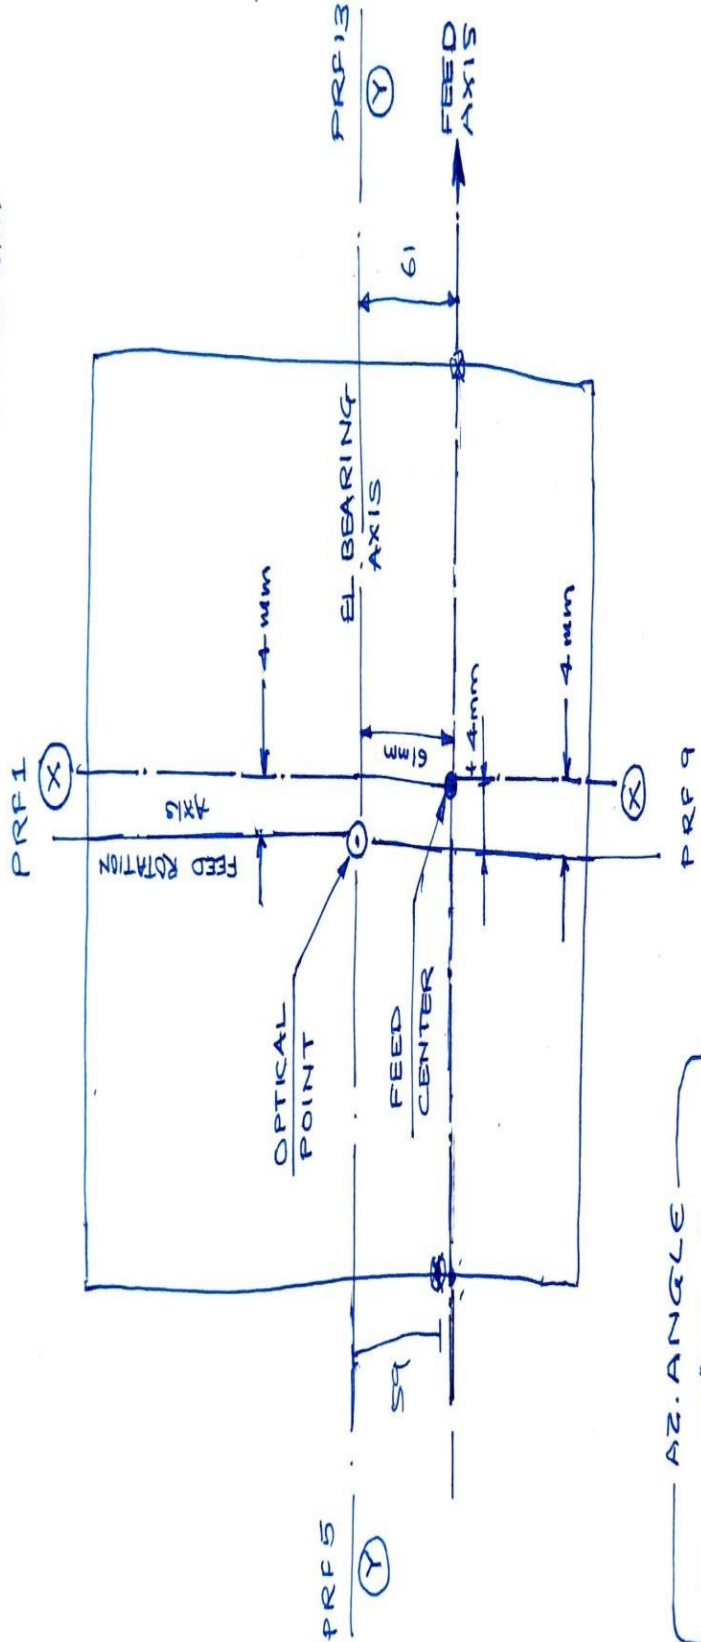
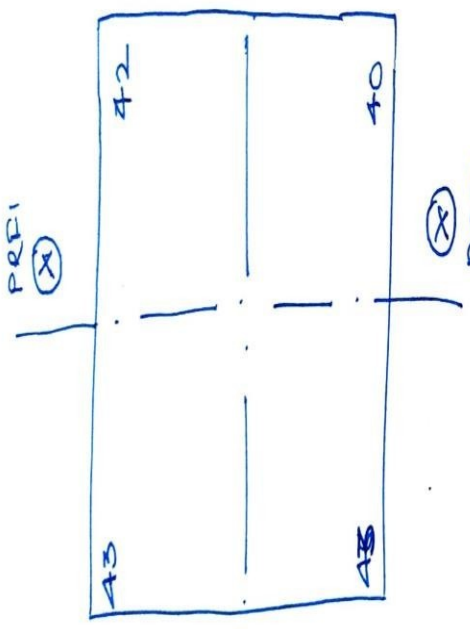
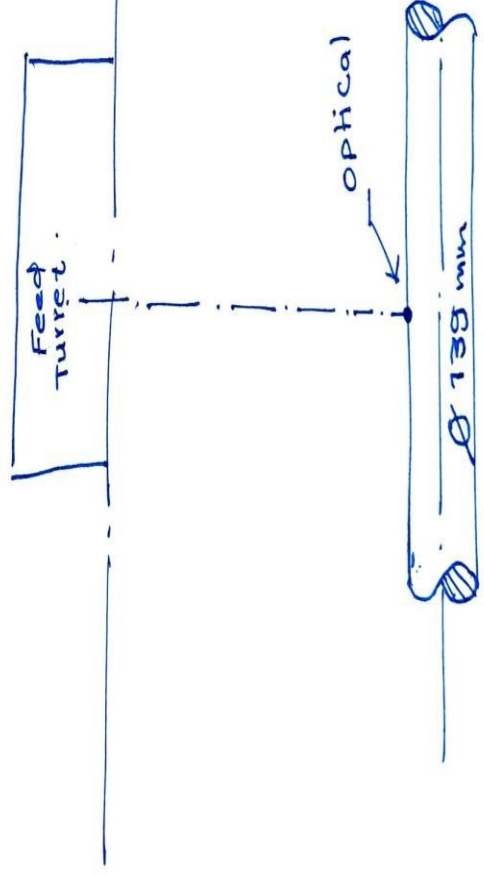
FEED POSITION IN X-Y AXIS  
 C03 ANTENNA

01	-	00° 00' 00"
13	-	89° 59' 54"
09	-	179° 58' 35"
05	-	269° 58' 26"

TURRET HEIGHT FROM EL. AXIS

1403.5 mm

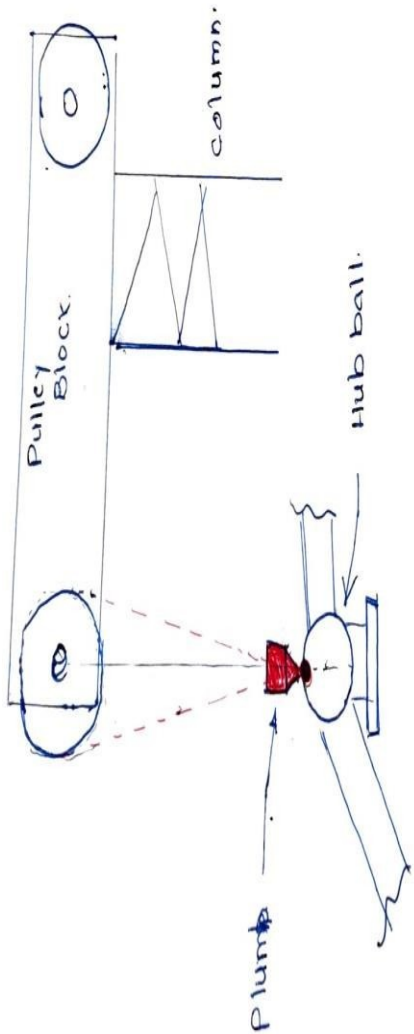
Sr. No.	Pulley Block No.	Plumb accuracy achieved.	After rectification if any.
1	Fixed on column A	3-4 mm	
2	Fixed on Column B	Within 3 mm	
3	Fixed on column C	20 mm. ⊗	3-4 mm.
4	Fixed on column D	2-3 mm.

⊗ - To be rectified & try to make within 5 mm  
 Pulley Block on column C → cleared.

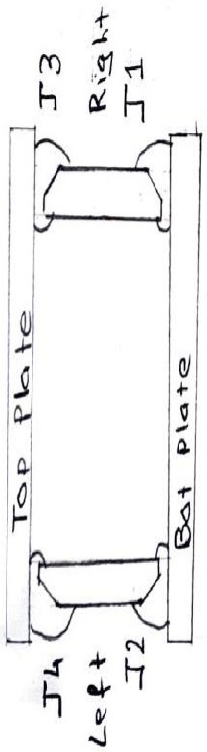
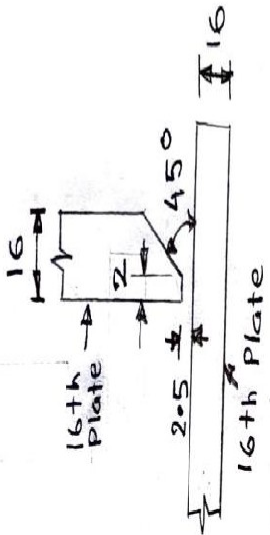
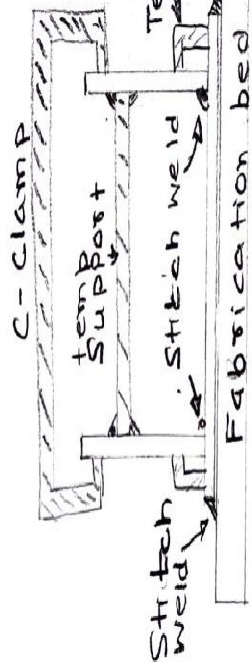
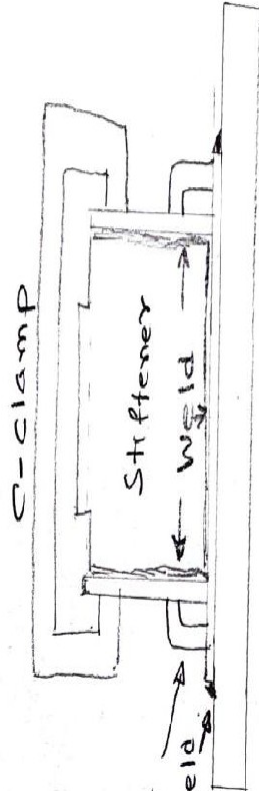
VALLEY BLOCK WELD DETAIL

Typical Joint detail for welding

Typical Fixture support for welding
